Assessment of Risk to Infrastructure from Permafrost Degradation and a Changing Climate, Ross River

Calmels, F., B. Horton, L.P. Roy, P..Lipovsky.and.B. Benkert, 2016. Assessment of Risk to Infrastructure from Permafrost Degradation and a Changing Climate, Ross River. Northern Climate ExChange, Yukon Research Centre, Yukon College.

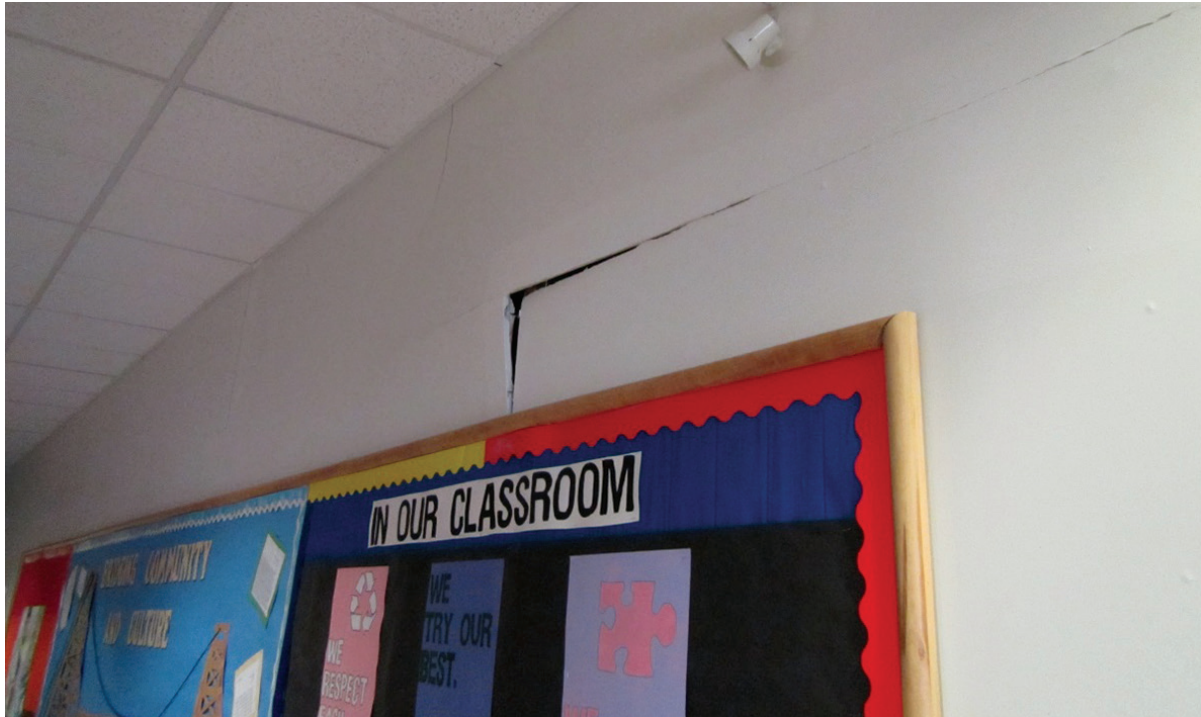
Figure 2.7.1.1 Damage to drywall in the northeast part of the school

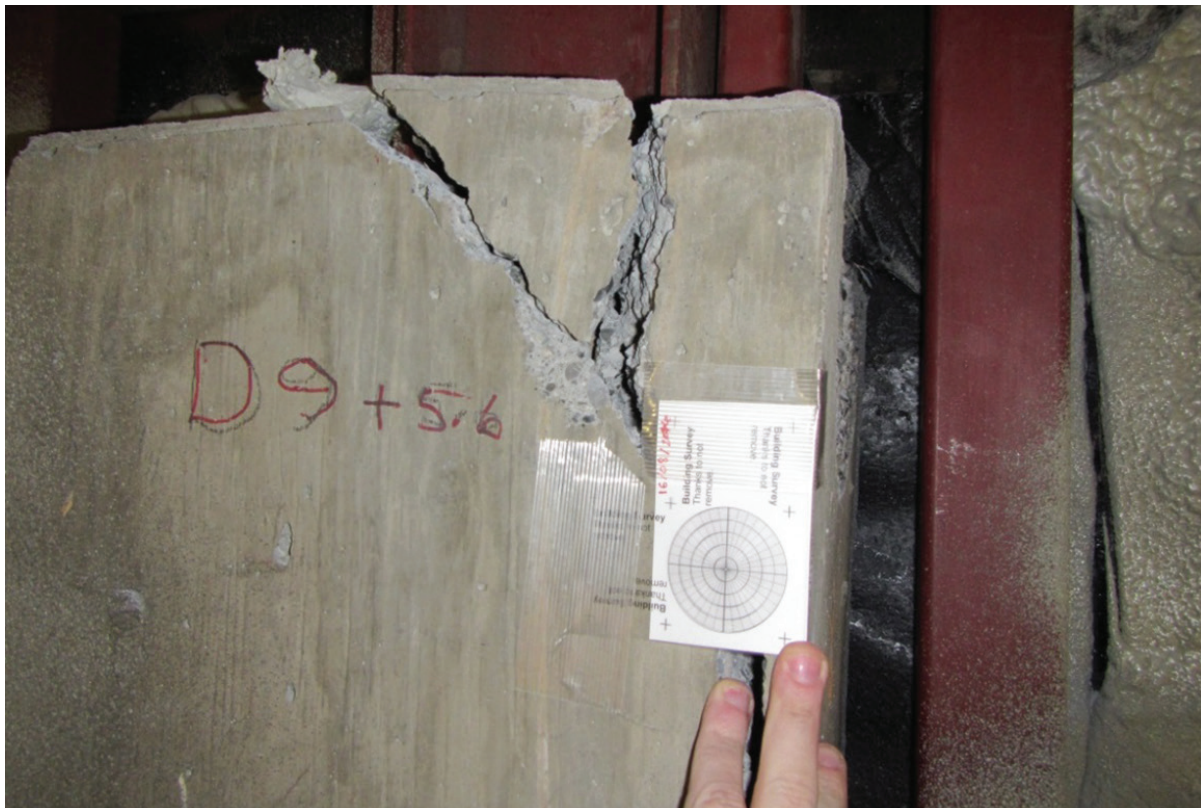
Figure 2.7.1.2 Damage to a concrete pier in the southwest part of the school

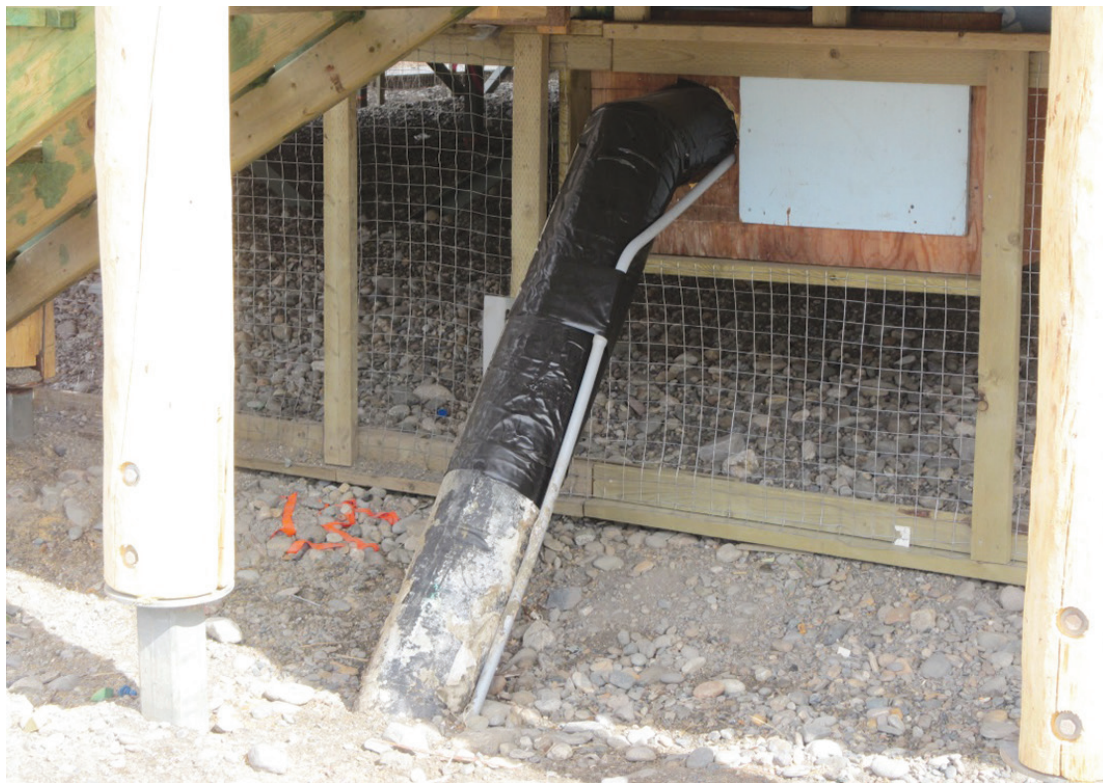
Figure 2.7.2.1 Repaired sewer line; sewer line had leaked for an unknown amount of time

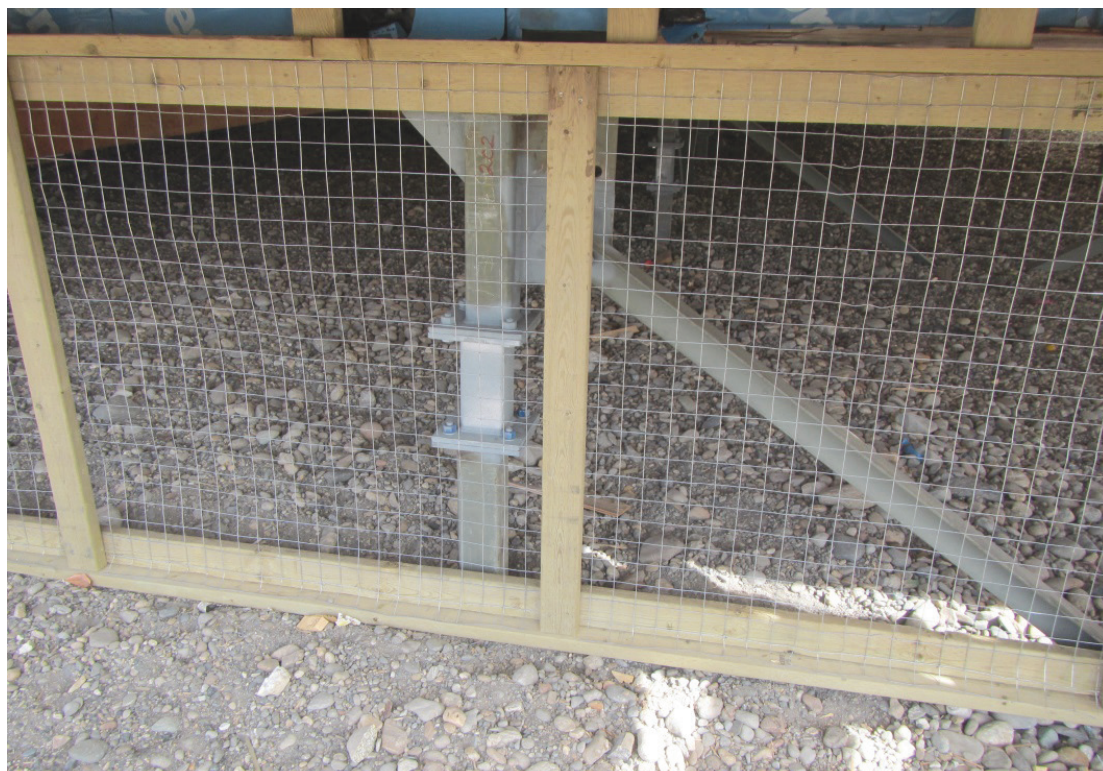
Figure 2.7.2.2 Extension added to piers on the community centre/daycare

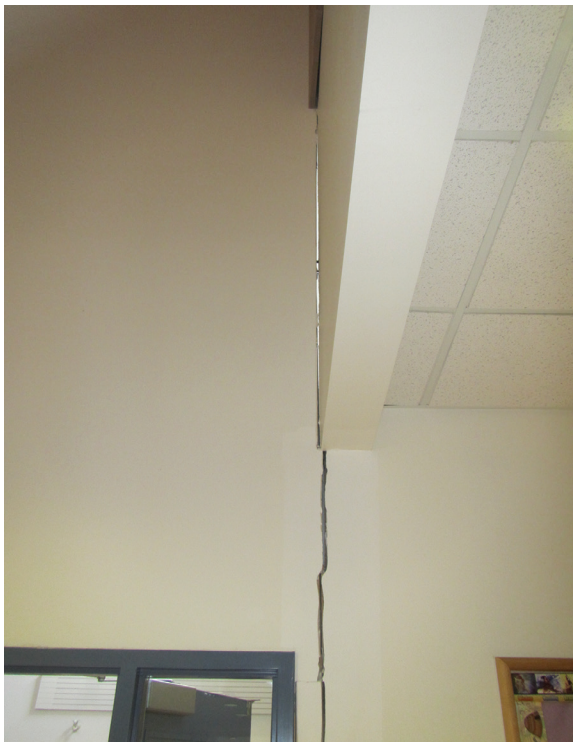
Figure 4.1.1 Cracked drywall, school

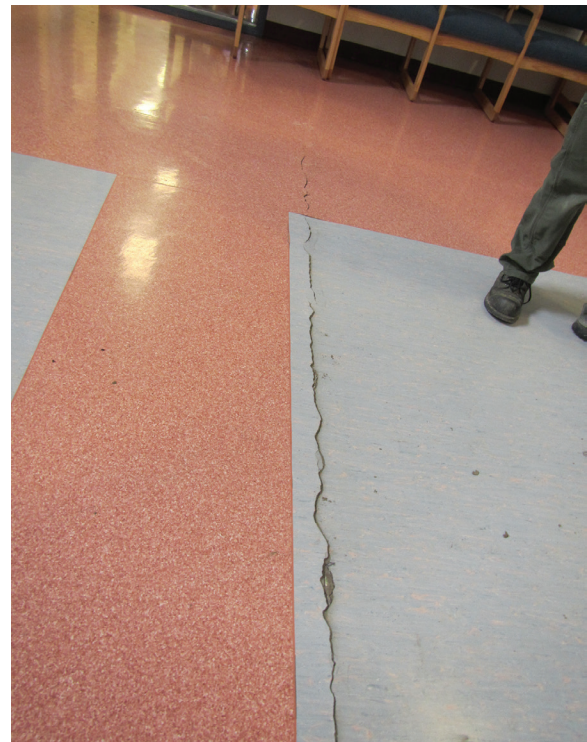
Figure 4.1.2 Cracks in the floor, school

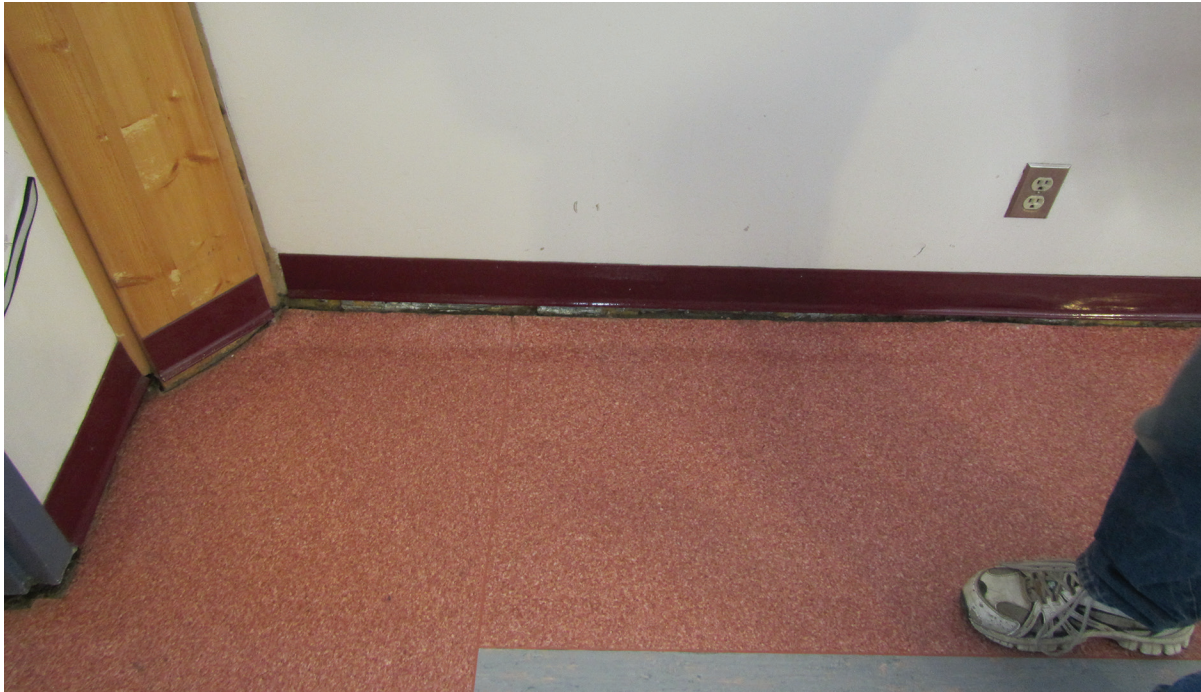
Figure 4.1.3 Gaps in joints between walls, and between walls and the floor, school

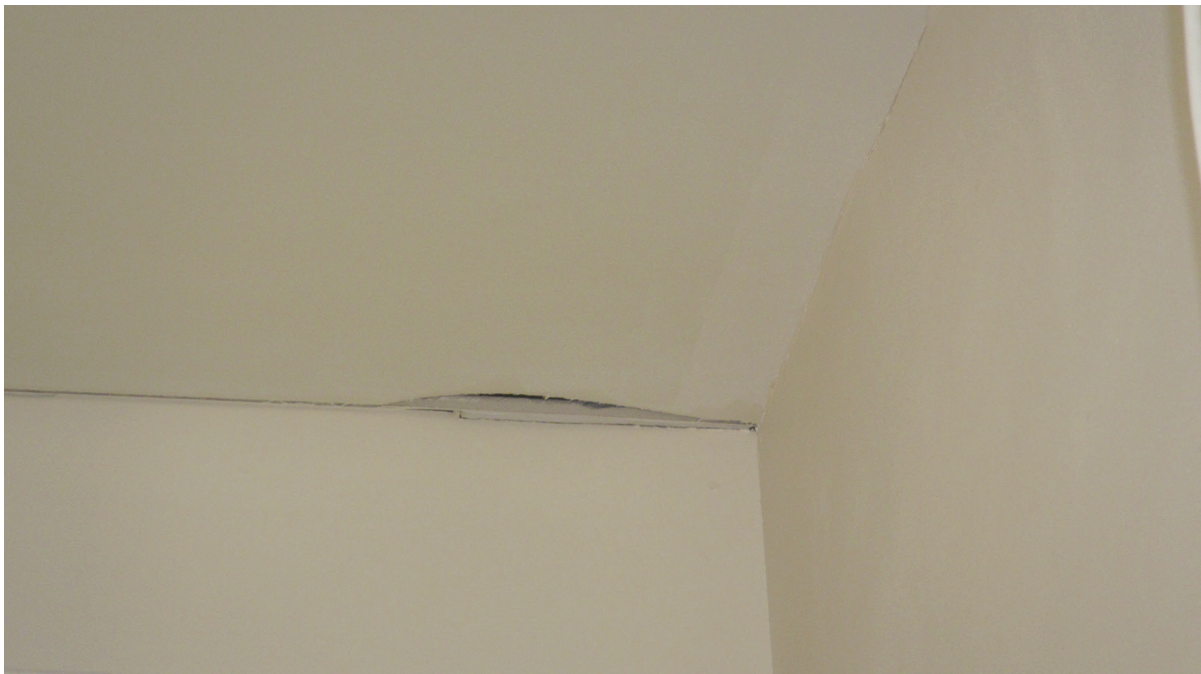
Figure 4.1.4 Small cracks between walls and ceiling, community centre

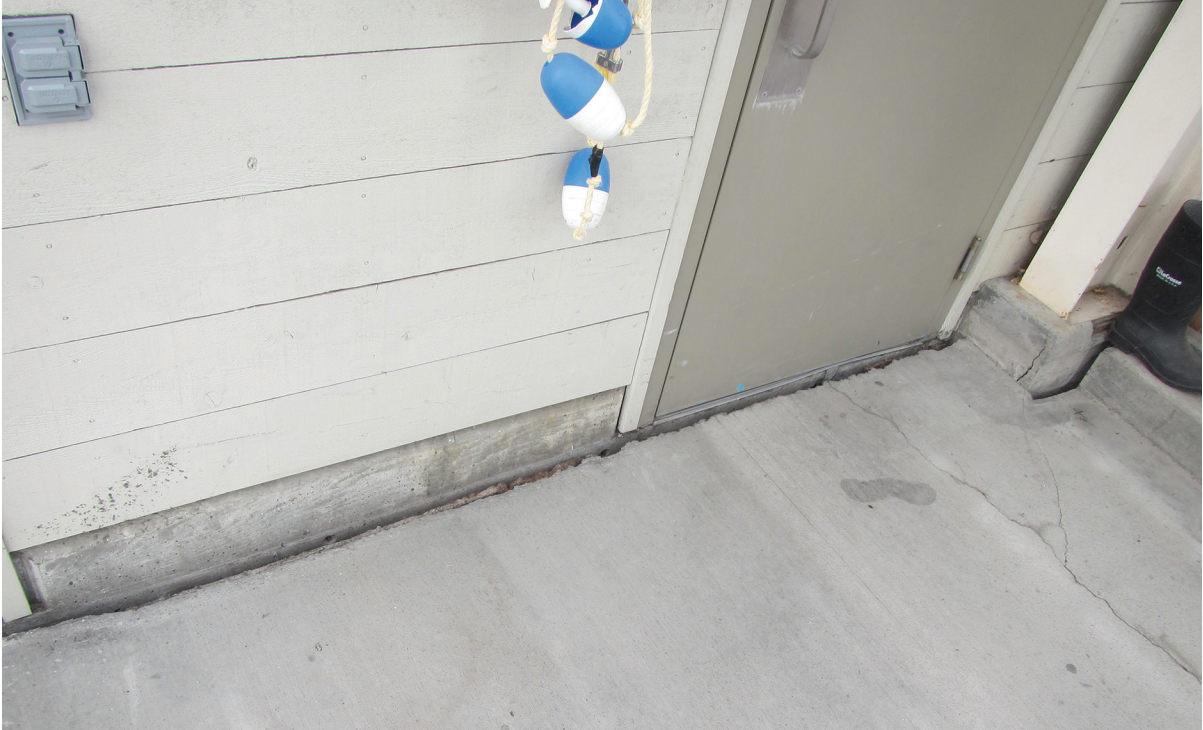
Figure 4.1.5 Gap between the wall and the floor, pool

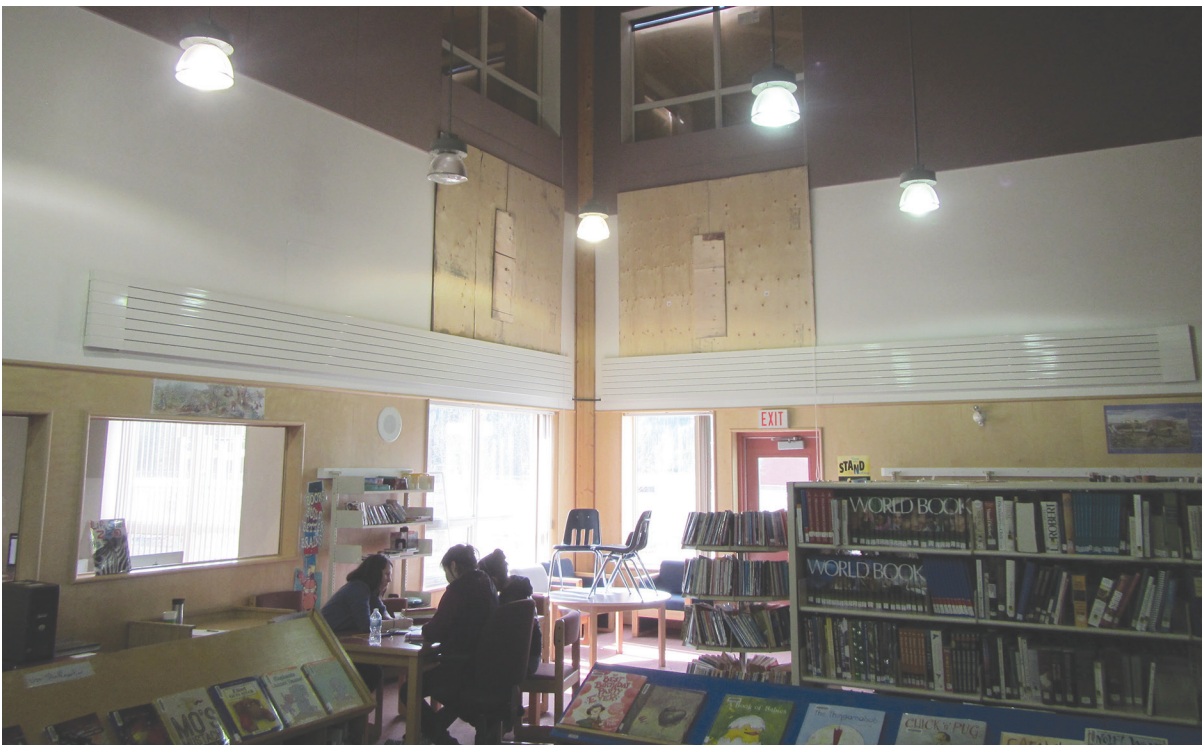
Figure 4.1.6 Window glass replaced by plywood, school

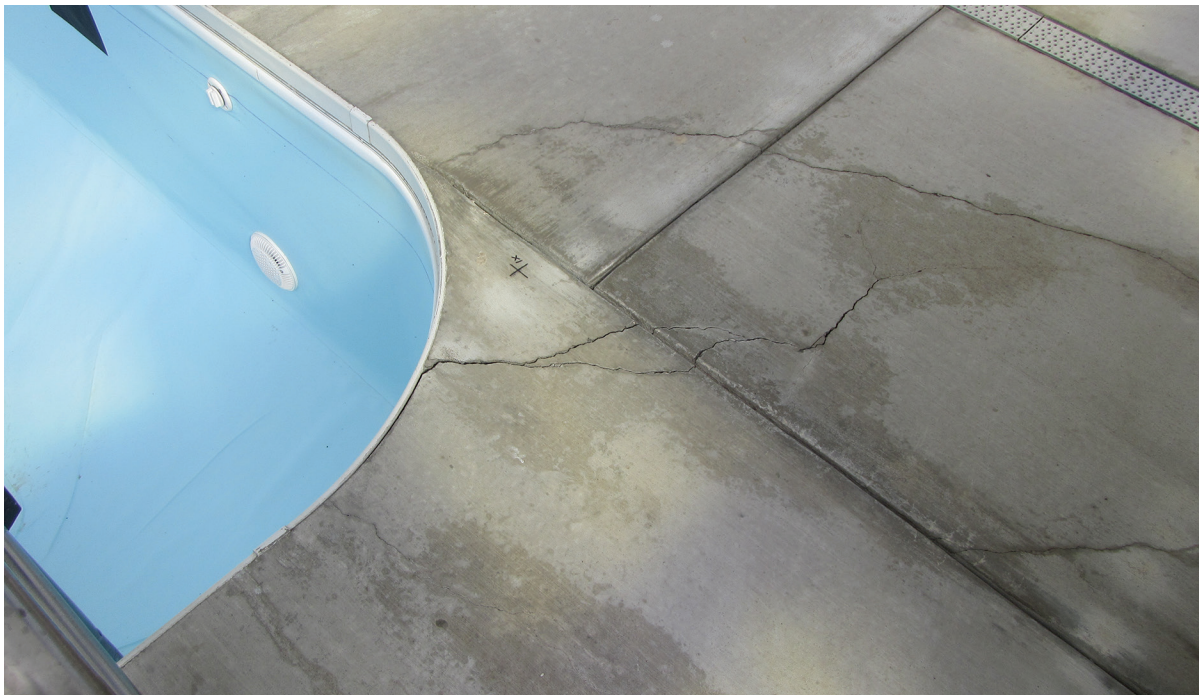
Figure 4.1.7 Cracks in concrete floor, pool

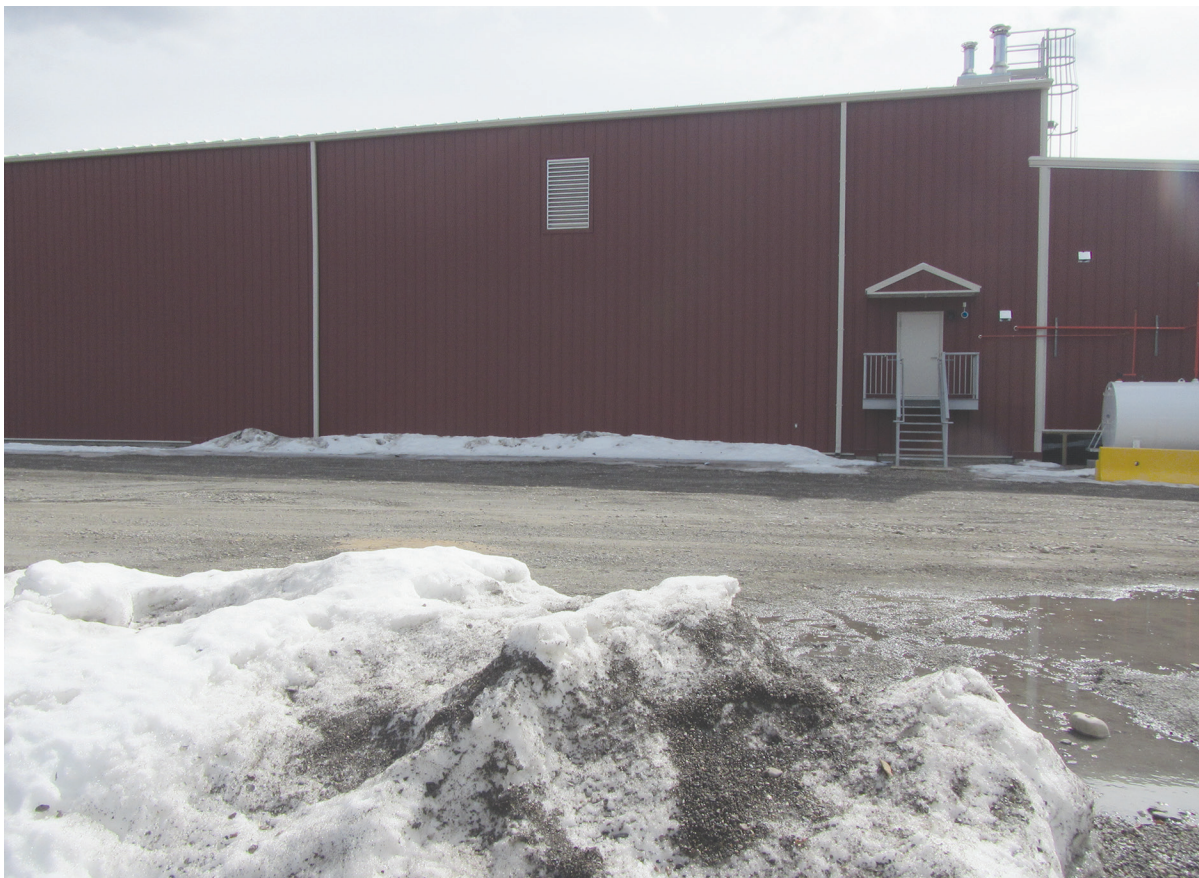
Figure 4.2.1.1 Remaining snow patches close to the north-facing side of the arena, April 2014

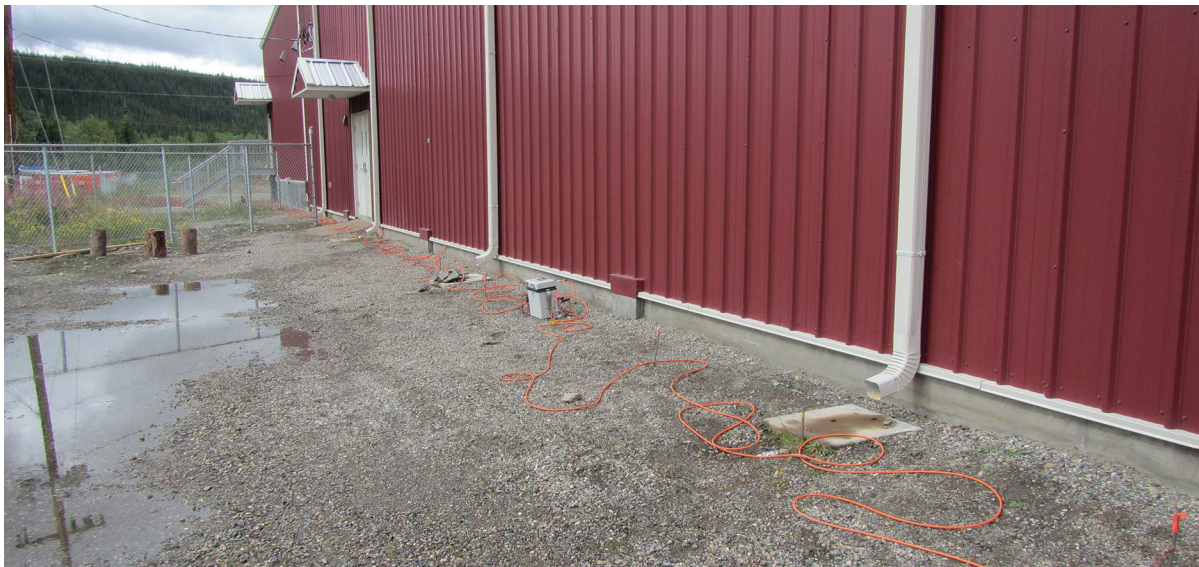
Figure 5.2 Water accumulation at the south side of the arena

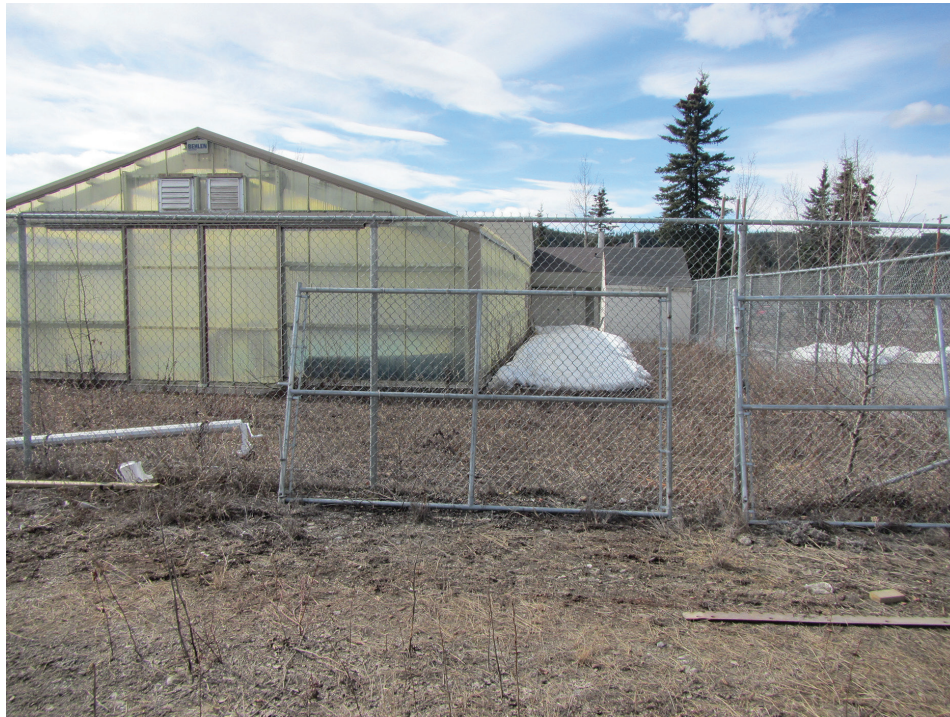
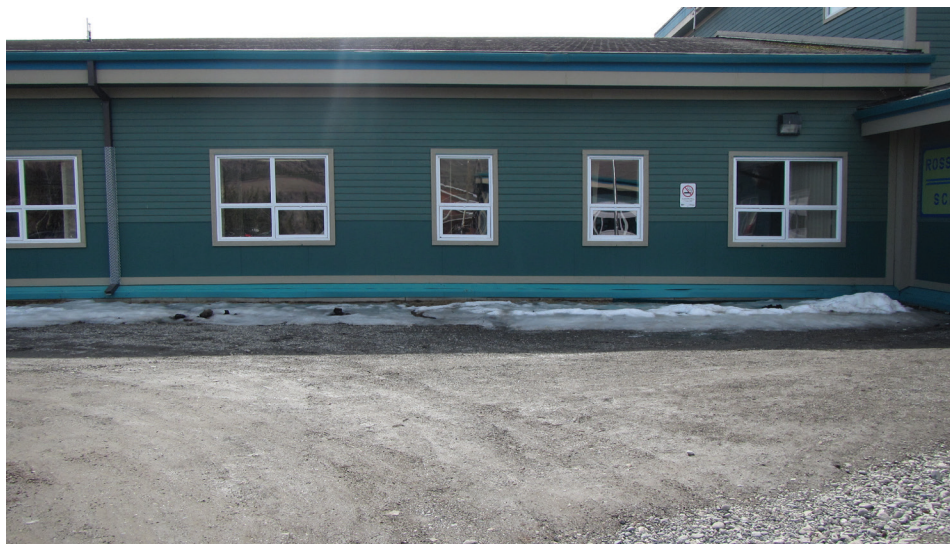
Figure 5.3 Snow accumulation on the north-facing side of the pool (above) and the school (below)
