# Old Crow landscape hazards

Geoscience mapping for climate  
change adaptation planning

**Northern Climate ExChange**  
YUKON RESEARCH CENTRE • Yukon College

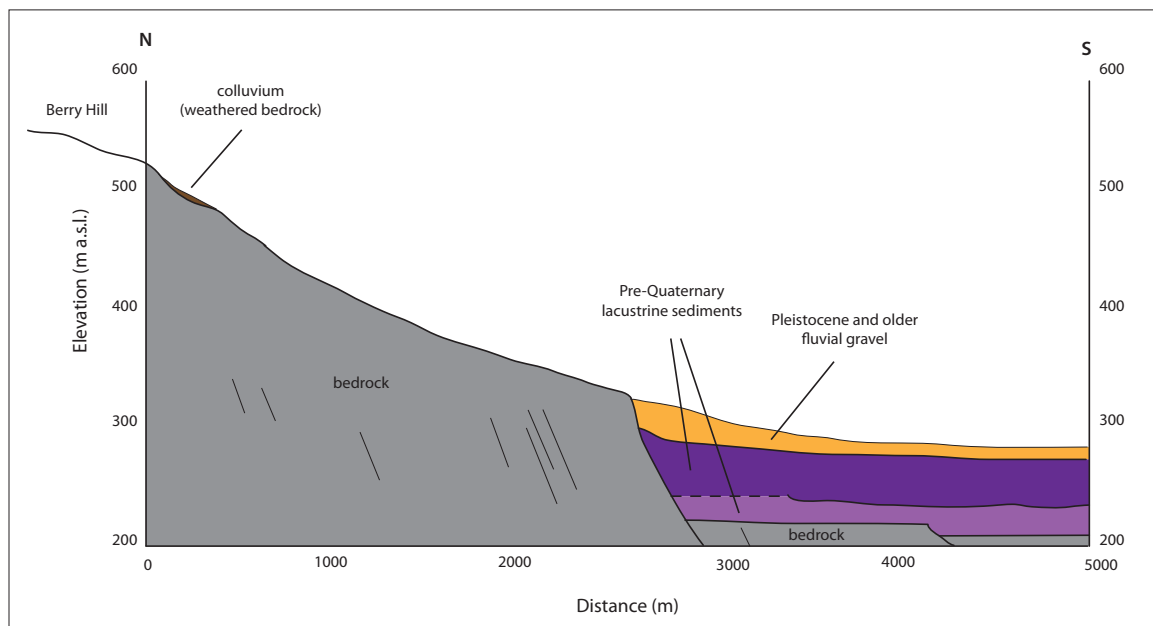
**Figure 9.** Idealized cross-valley profile of what the Old Crow basin might have looked like at the end of the Neogene when rivers and lakes had filled the basin with sediment.

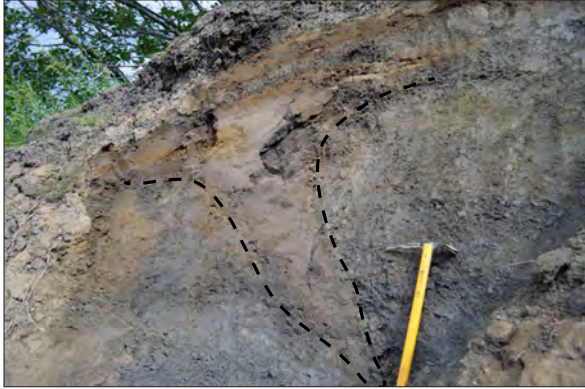
**Figure 10.** Evidence of periglacial conditions are recorded by ice wedge casts which formed when frost cracks fill with sediment.

The cold conditions of the Pleistocene Epoch are recorded in the study area by a transition from temperate to cold-climate pollen records (Lichti-Federovich, 1973; Schweger and Matthews, 1991) and preserved periglacial features such as ice wedge casts that record thermal cracking of the ground surface (Figure 10). The modern course of the Porcupine River is thought to have been established during the late Pleistocene when glacial lakes overflowed into the Old Crow Basin and cut a new western outlet to the Yukon River (Hughes, 1972; Duk-Rodkin et al., 2004). Prior to this diversion, regional streams drained eastward into the paleo-Mackenzie River. When the most extensive advance of the Laurentide Ice Sheet occurred in the late-Pleistocene, it blocked drainage through the Richardson Mountains and impounded a large glacial lake in the Old Crow, Bell, Driftwood and Bluefish basins (Figure 11; Hughes, 1972; Zazula et al., 2004). Strandlines to at least 360 m a.s.l. in the Old Crow basin mark the high stand of glacial Lake Old Crow ~15,000 to 20,000 years ago, before incision of the Ramparts of the Porcupine River drained the lake and established the modern course of the Porcupine River and its tributaries (Figure 12; Kennedy et al., 2010; Thornson and Dixon, 1983).

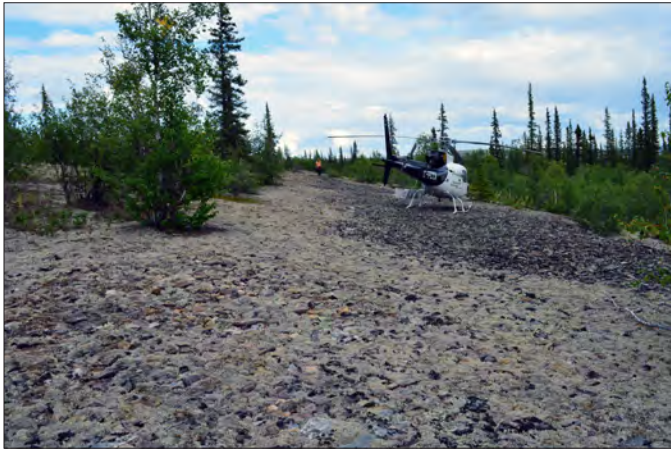
**Figure 12.** Beaches of washed gravel ~10 km southeast of Old Crow mark the high stand of glacial lake Old Crow at ~360 m a.s.l.

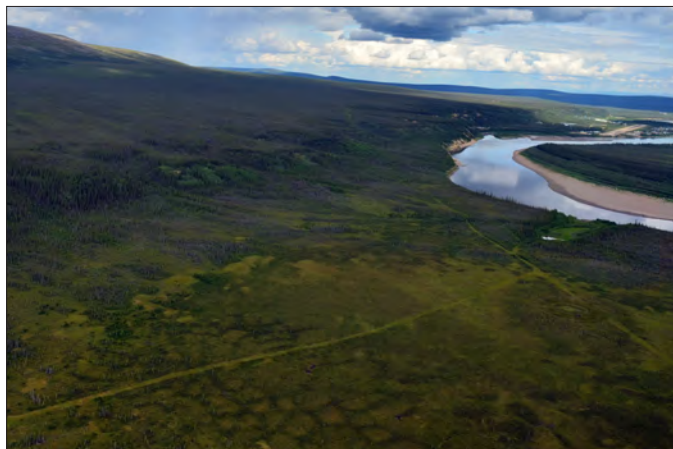
**Figure 15.** Holocene changes to the landscape include valley-side colluvial deposits and the growth of peat and permafrost on the valley floor. Ice-wedge polygons are visible in the foreground of this photo looking northeast toward the community of Old Crow.

Holocene landscape evolution in the study area was modified by the amelioration of periglacial conditions and a gradual infilling of the Porcupine River valley margins (Figure 14). Valley-side colluvial deposits and abandonment of the high terraces along the Porcupine River resulted in the modern, broad, poorly drained valley floor (Figure 15). Landscape evolution of the Old Crow map

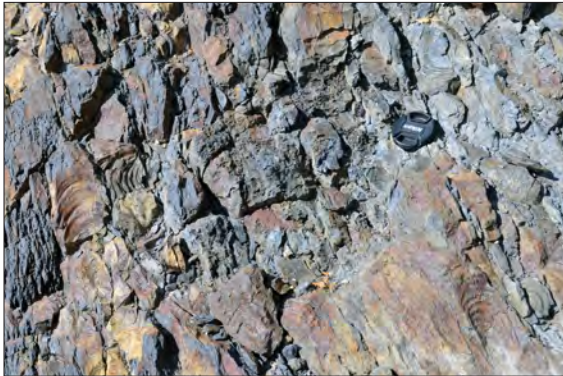
**Figure 16.** Siltstone of the Jurassic-aged Husky Formation is visible in outcrop along the lower Crow River. Abundant fossil shell imprints are visible. Lens cap for scale.

Bedrock in the map area consists of Neoproterozoic (~800 Mya) and Jurassic (~180-145 Mya) clastic and carbonaceous sedimentary rocks. The Neoproterozoic Katherine Formation is characterized in North Yukon by mature, very fine-grained, thin to thick-bedded, brown, greenish grey and white orthoquartzitic sandstone with recessive intervals of shale and rare dolostone. Comprising Berry Hill and the gentle slopes below it, this distinctively white rock is the primary source for crush, rip-rap and other aggregate needs for the community of Old Crow. The Jurassic-aged Porcupine River member of the Husky Formation is in fault contact with this unit. Characterized as dark grey siltstone and shale (Norris, 1985; 1997), this unit outcrops on the west bank of the lower Crow River just above the community of Old Crow (Figure 16).

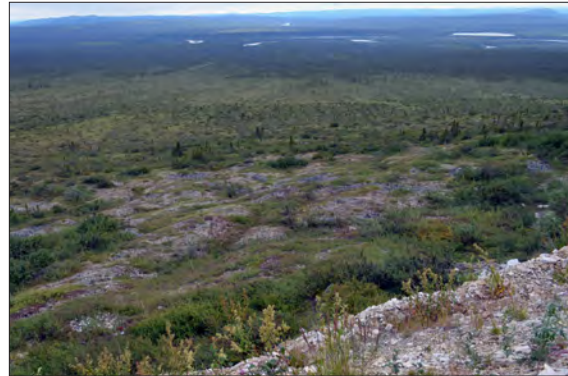
**Figure 17.** Weathered bedrock is the dominant material type in the highest parts of the map area. In this photo, crushed sandstone bedrock is visible in the foreground, weathered bedrock is visible in the middle ground, and the colluvial plain of the pediment slope is visible in the far distance.

Much of the bedrock in the uplands surrounding and making up Berry Hill is mapped as ‘weathered bedrock’ (D; Figure 17). Weathered bedrock frequently forms deposits of blocks and boulders within a silty matrix that were created through frost shattering, colluviation, and chemical weathering processes. Weathered bedrock units typically contain a component of loess-derived silt and are subject to sorting and mixing from cryoturbation and other periglacial processes.

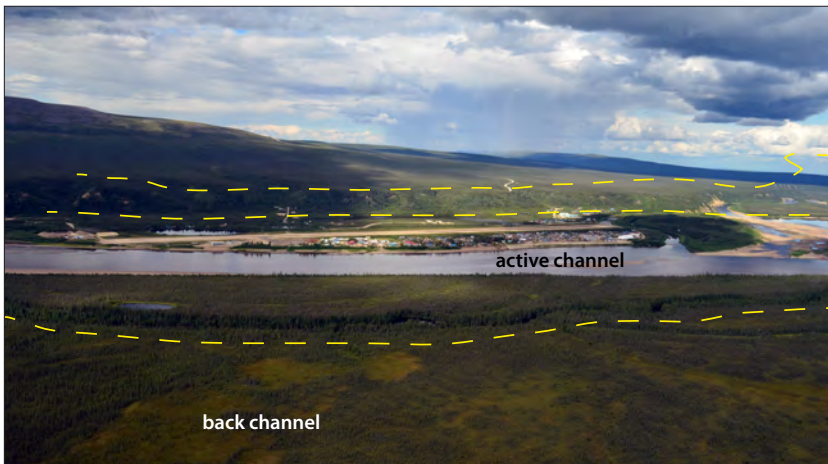
**Figure 18.** Both active-channel gravel deposits and back-channel depositional environments are pictured here. Abandoned meanders of the Porcupine River gradually fill with silt and sand to become poorly drained and ice-rich parts of the floodplain.

Active Holocene fluvial deposits (FA) comprise sand and gravel stream materials that are subject to regular flooding. These deposits include both coarse channel materials and fine overbank flood deposits (Figure 18). Main channel gravel deposits are moderately to well sorted, and contain clasts that are rounded and imbedded in a sandy matrix (Figure 19). Overbank deposits are represented by fine-grained sediments of silt, sand and organics that are massive (lacking structure) to thinly laminated and may contain interbeds of gravel (Figure 20). In the study area, fans, or complexes of coalesced fan-shaped landforms, are usually dominated by colluvial processes although fluvial transport does contribute to their formation. Fans typically consist of large amounts of silt, sand, and gravel colluvium derived from units of stratigraphically higher positions.

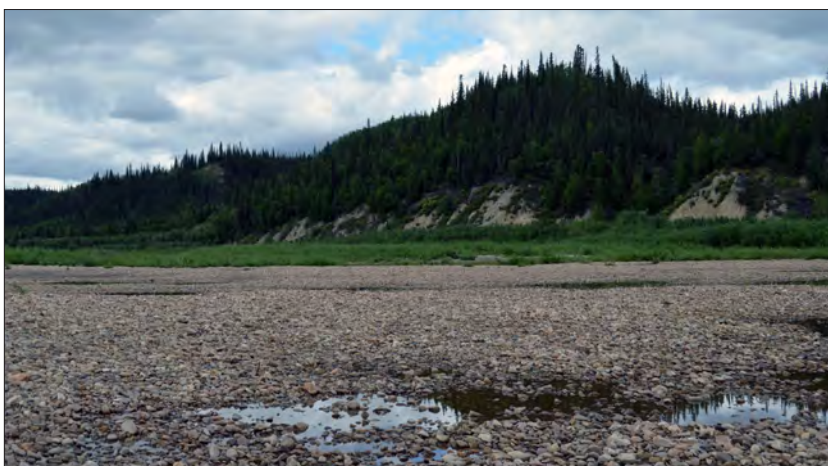
**Figure 19.** The active channel of the Porcupine River is characterized by moderately rounded and well-imbricated pebble and cobble-sized clasts.

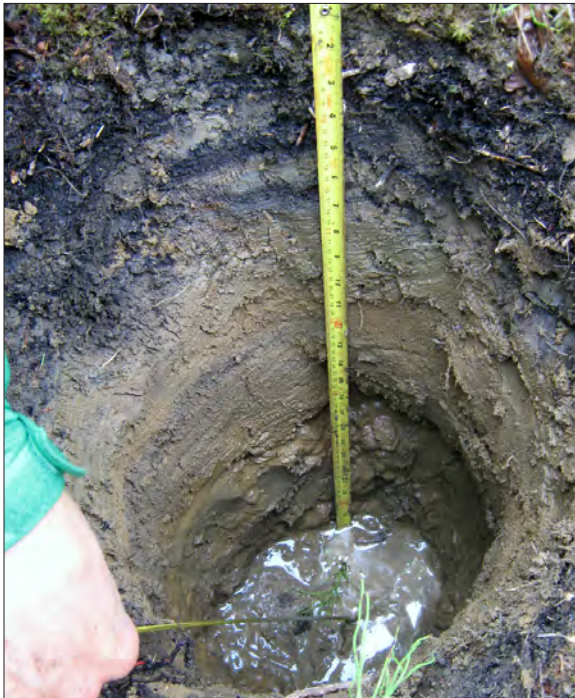
**Figure 20.** This soil pit dug in the back-channel part of the floodplain in Old Crow (near the ski trails) has fine, silt-rich soil and a shallow active layer. At this site, the water table was encountered 45 cm below the top of the moss mat where it was perched above a ~65 cm deep permafrost table.

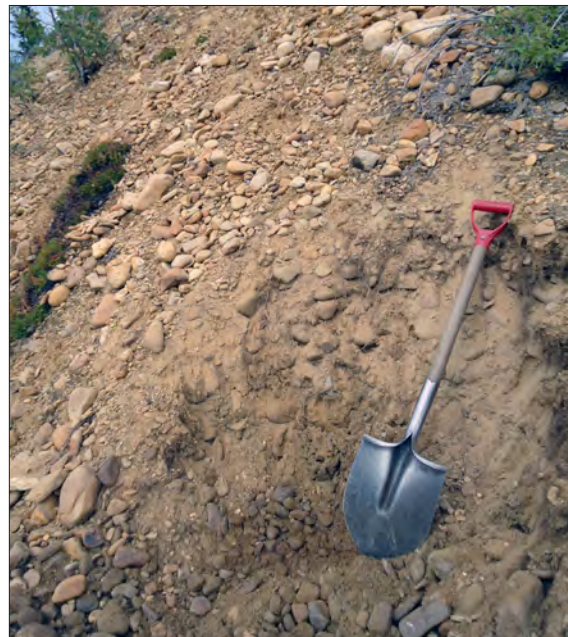
**Figure 22.** Matrix and clast-supported facies of pebble-cobble gravel deposited above ~280 m a.s.l. on the escarpment above town.

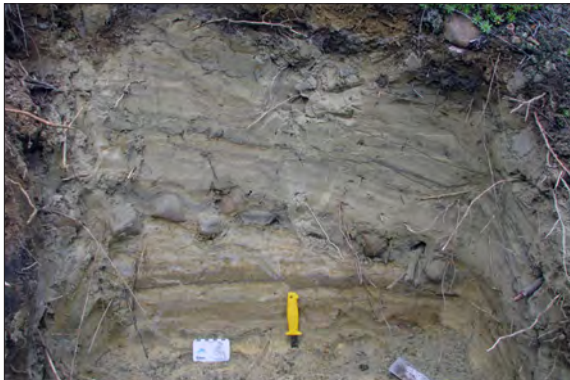
**Figure 23.** An exposure of a sand facies in the high-level fluvial deposits has an erosional cobble lag surface which is draped by angled sand beds that may have been deposited as slopewash.

can be both open-work and matrix-supported (Figure 22). Discontinuous sand units are usually 2-3 m thick and poorly exposed. Where visible, sand beds contain features such as cobble lags and cut-and-fill structures that may be related to colluvial slopewash (Figure 23).

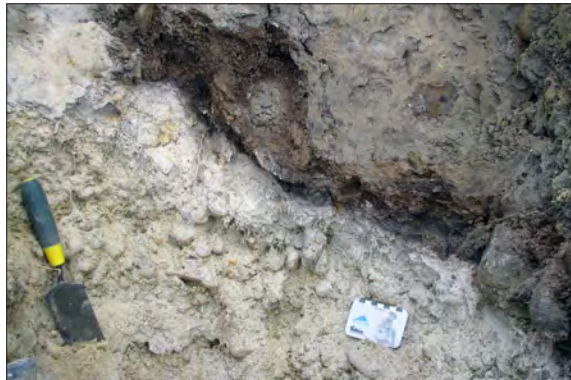
**Figure 24.** Organic material (dark brown) and altered parent materials (white quartz sand) at the top of the high-level gravel where it is buried by ~5 m of diamict.

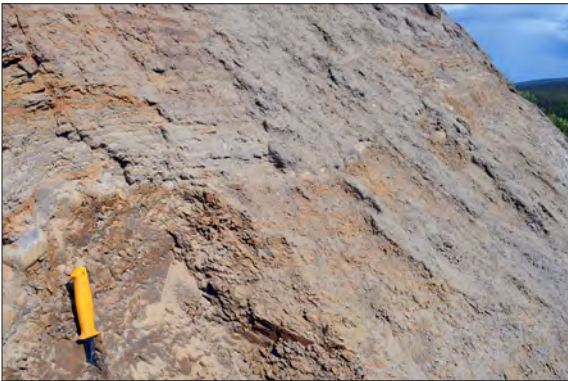
**Figure 25.** A large exposure of lacustrine silt above the lower Crow River. One bed containing cobble-sized clasts was observed in this silt-dominated unit and is pictured here.

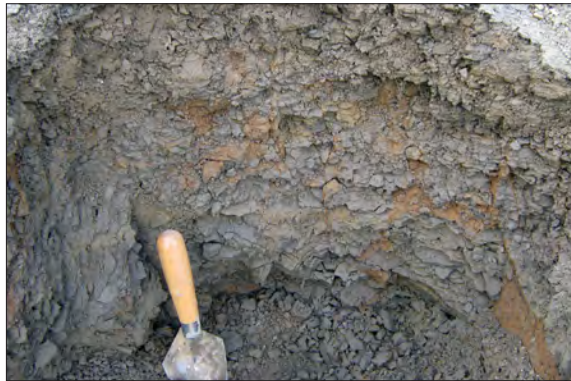
**Figure 26.** Neogene-aged lacustrine silt exposed in a pit along the escarpment above town. The unit is well indurated and friable with fracture planes commonly weathered to a rusty orange colour.

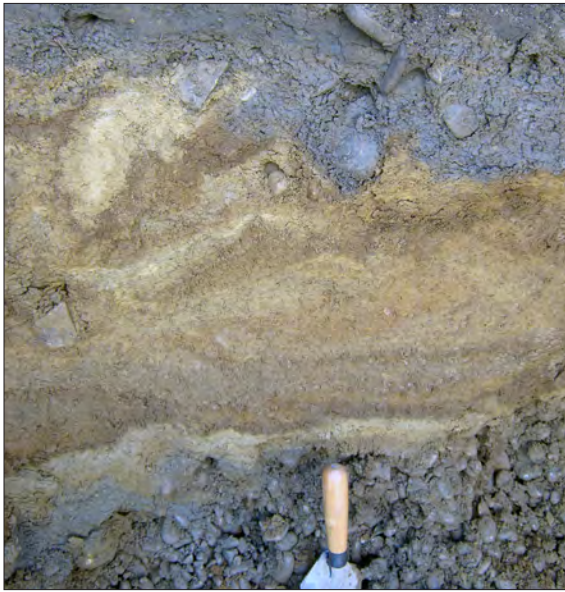
**Figure 27 (left).** Silt-rich diamict is the highest stratigraphic unit on the escarpment above town and is interpreted as a colluvial deposit generated on the pediment slope above. The thickness of this unit is thought to be controlled by the depth of cryoturbation that occurs in the active layer above the permafrost table. The underlying sand unit in this photo has disturbed bedding near its contact with overlying silt, but relatively undisturbed beds below where they have been preserved by permafrost.

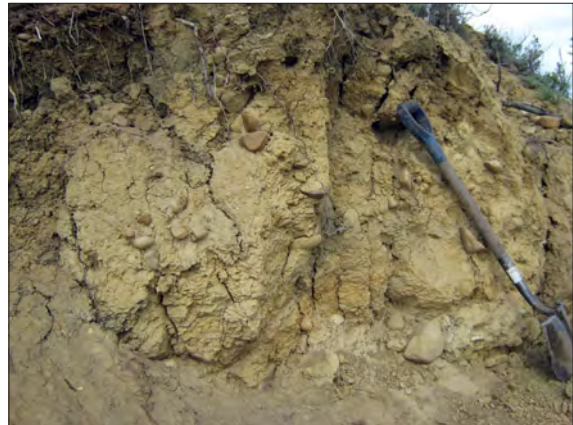
**Figure 28 (above).** Colluvium comprised of resedimented fluvial gravel can contain well-rounded clasts such as the ones pictured here.

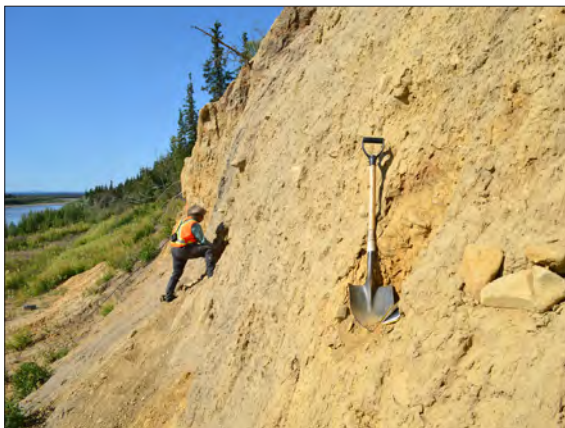
**Figure 29 (above).** Coarse angular clasts and a silty matrix are typical of colluvium deposited by rapid mass movement processes. This deposit is located at the mouth of a gully.

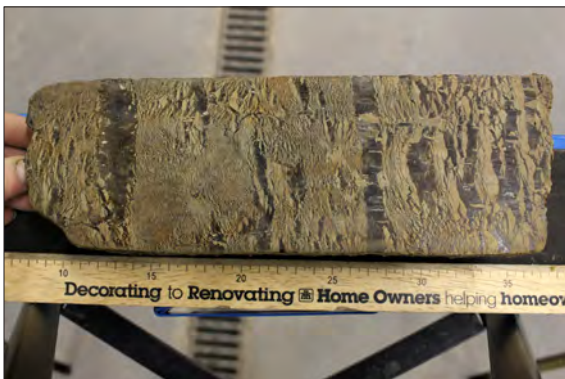
**Figure 30 (above).** Dark grey ice in tan silt; deposited on a colluvial landform near Ski Chalet Road.

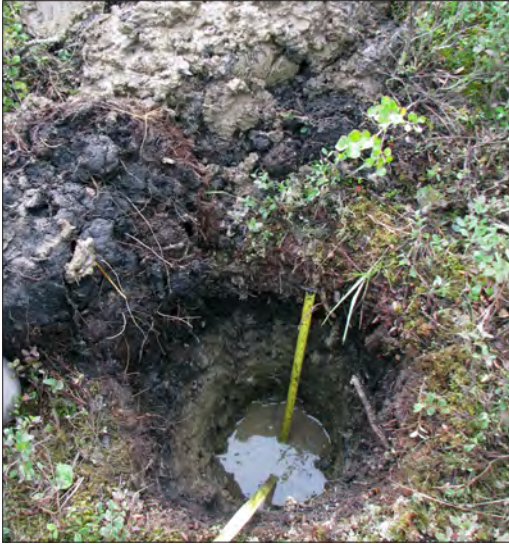
**Figure 31 (left).** A thick organic mat (more than 20 cm) on this valley bottom site creates cold, saturated ground conditions with permafrost near surface.

limited areas on floodplains or shallow fluvial channels where soils are modified by near-surface permafrost. Veneers of organic material (20 to 100 cm thick) are widespread in the map area, and though not mapped, are present on most flat to gently-sloped surficial deposits (Figure 31).

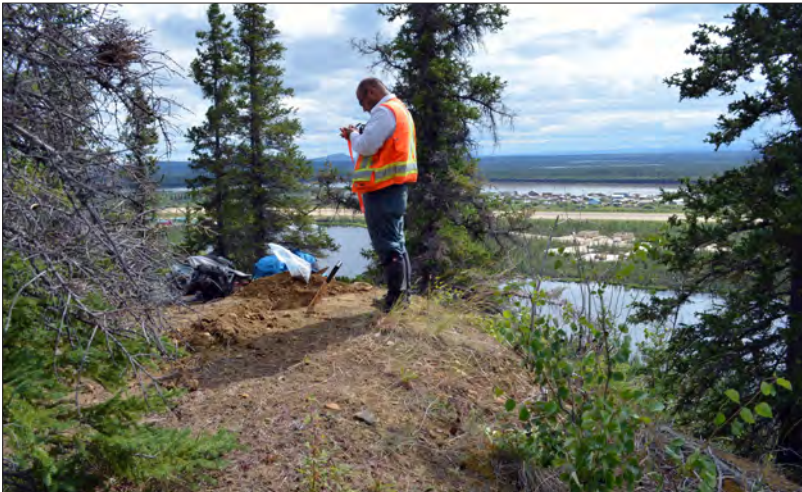
**Figure 32 (left).** Eolian sand and silt often accumulates in thicker deposits on ‘cliff-top’ locations like this where wind blows up exposed sediments from the steep slope below. In this photo, silt is enriched in a gravel soil.

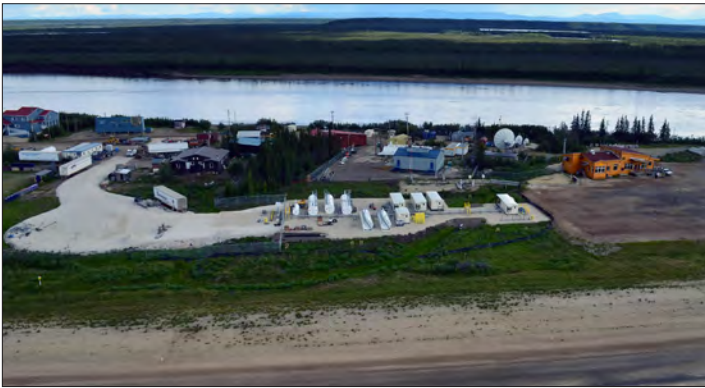
**Figure 33.** Thick aggregate building pads are an example of anthropogenic deposits in Old Crow. The airport is the biggest continuous area composed of anthropogenic materials, and much of the downtown core contains anthropogenic deposits of aggregate.

Anthropogenic deposits are surface materials modified by human activities such that their original physical properties have been significantly altered (Howes and Kenk, 1997). Anthropogenic deposits in the map area include areas with significant quarried rock on the surface such as the sewage lagoon, and where aggregate used for building pads has largely replaced natural materials (Figure 33).

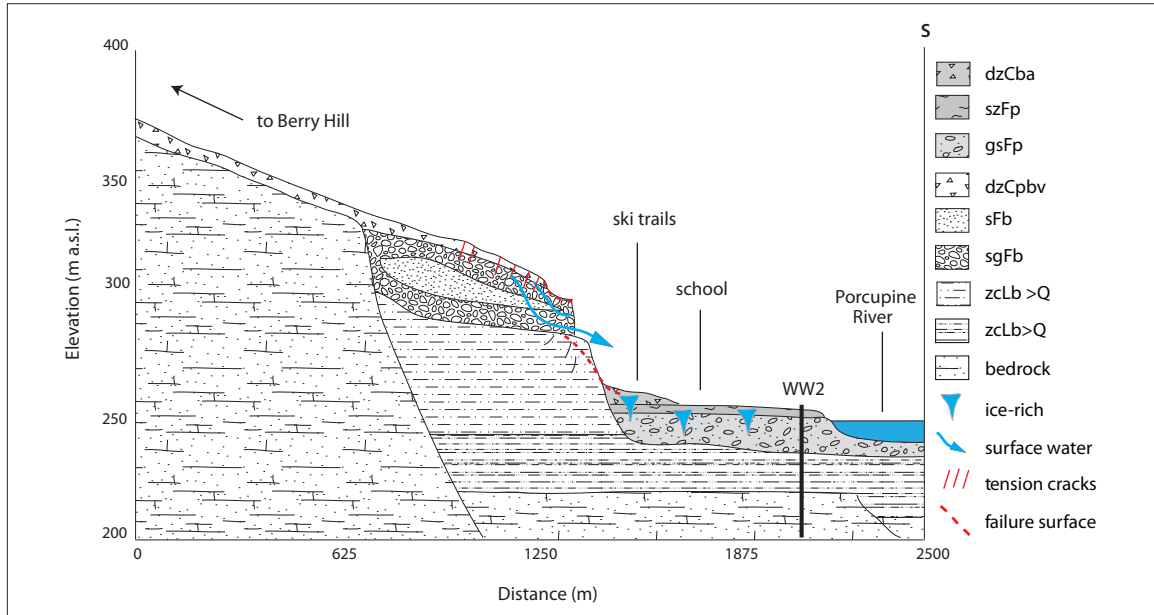
**Figure 43.** Idealized cross-valley profile of the map area with unit textures and landform descriptions. Landslide mechanisms are controlled by the vertical distribution of surficial materials on the escarpment behind town.

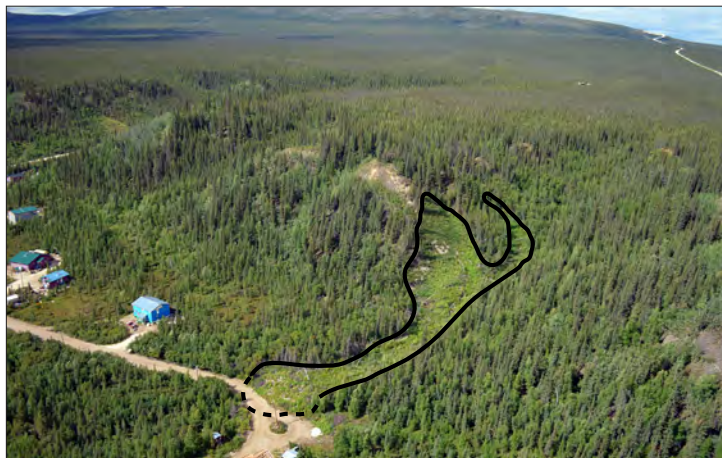
**Figure 44.** A photo taken in 2015 of bright green colonizing vegetation covering the surface of the active layer detachment slide called “Rosalie’s Slide” that occurred in August 2010.

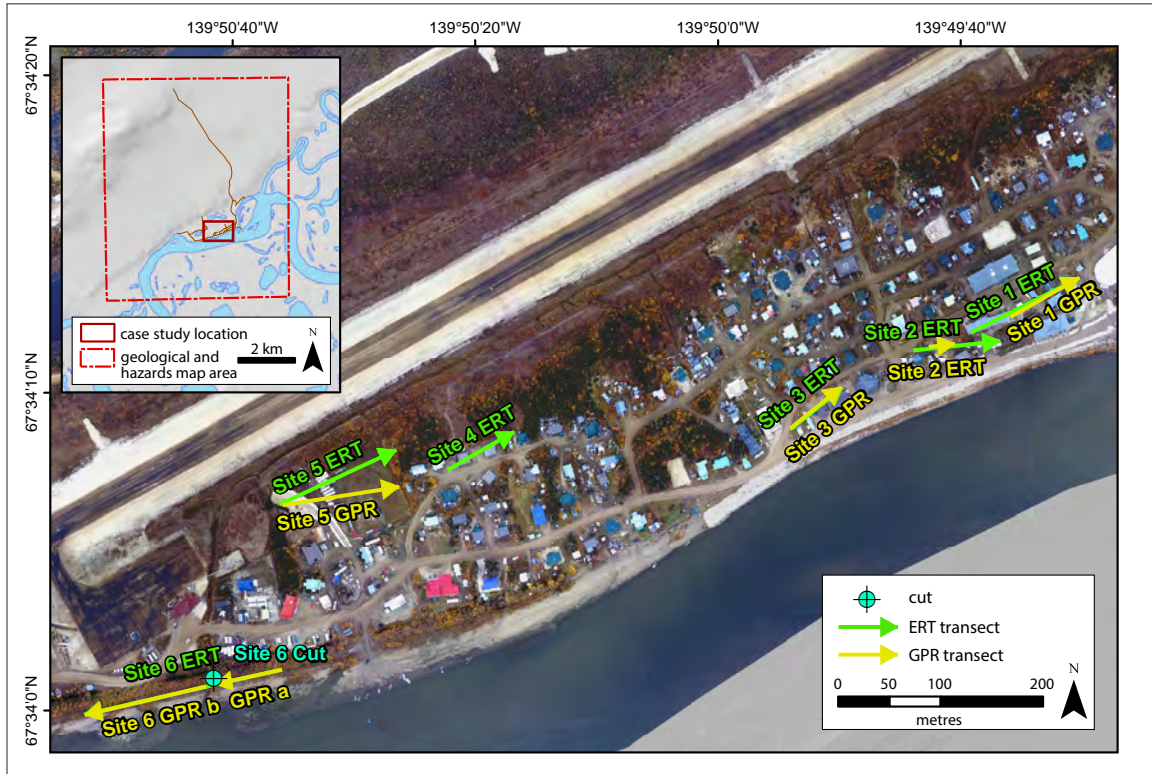
**Figure 51.** Overview map of case study sites 1 to 6 in the Old Crow community core area.

The Old Crow community core encompasses sites 1-6 (Figure 50; Figure 51). Results from field investigations at each site are described below.

Groundcover at Site 1 was mainly composed of gravel material, used for construction of building pads for the John Tizya Centre and the arena. A 120 m-long ERT survey was run underneath the John Tizya Centre to the arena, and a GPR survey followed the same line, but its start point is located just beyond the John Tizya Centre (see Figure 51).

Site 2 is situated in an area that was formerly occupied by a residential home that burned down in March 2014. The ground at the site was scattered with burned debris, gravel patches and garbage. A thin vegetative ground cover was composed of mosses and grasses, and some patches of taller dry grasses. ERT and GPR surveys were both run in an easterly direction over the abandoned lot southwest of the John Tizya Centre (see Figure 51 for location).

This site is the location of a proposed multiplex. GPR and ERT surveys were run along the north side of the former Northern Store (see Figure 51 for location). The first part of both surveys was conducted on grass-covered gravel, while the remaining part of the surveys crossed exposed gravel pads.

Site 4 is located east of the tank farm where there are two abandoned log homes (see Figure 51 for location). An ERT survey was run under the two log buildings. The survey was conducted mainly on the gravel pads and crossed a shallow ditch at its eastern end (Figure 59). The 76 m-long ERT survey revealed a continuous low-resistivity layer 4-5 m thick overlying high-resistivity material that extends to the base of the profile at a depth of 13 m. The profile is interpreted as having a subsurface of deep seasonal thaw, or a supra-permafrost talik that overlies permafrost. The substantial thaw of the permafrost is clearly linked to the structural damage evident in the log homes and it is therefore assumed that the soil that has thawed contained excess ice.

Site 5 is located at the new tank farm (see Figure 51 for location). Here, GPR and ERT surveys were run in an eastward direction, beginning a few metres from the airport fence, through the former playground and between the oil tanks, and ending at another fence in the baseball field. No fill materials were present at the time of the investigations, and groundcover consisted solely of grass.

Site 6 is located at the southwestern edge of the community, on the upper part of the north bank of the Porcupine River (see Figure 51 for location). One 200 m-long ERT transect was conducted in an east to west direction along the shore, and across a small gully (~6 m wide at its widest part). A two-section GPR transect was run along the same line as the ERT survey; however, the two GPR surveys are separated by the gully (see *GPR a* and *b* on Figure 51). The transects followed a narrow discontinuous path with a gentle slope to the south. Where the profiles crossed the gully, centimetre-wide tension cracks were visible on either side. The ground was covered with moss, grasses, scattered branches and pebble to cobble, subrounded gravel. Willow and alder shrubs were abundant along most of the pathway, reaching up to 2 m on the south side, and up to 4 m on the north side. A 220 cm-high exposure in the gully was investigated about 10 m inland from the stream outlet (see Site 6 cut on Figure 46). The site is situated on overbank deposits, composed of stratified layers of silty sand and subrounded gravel.

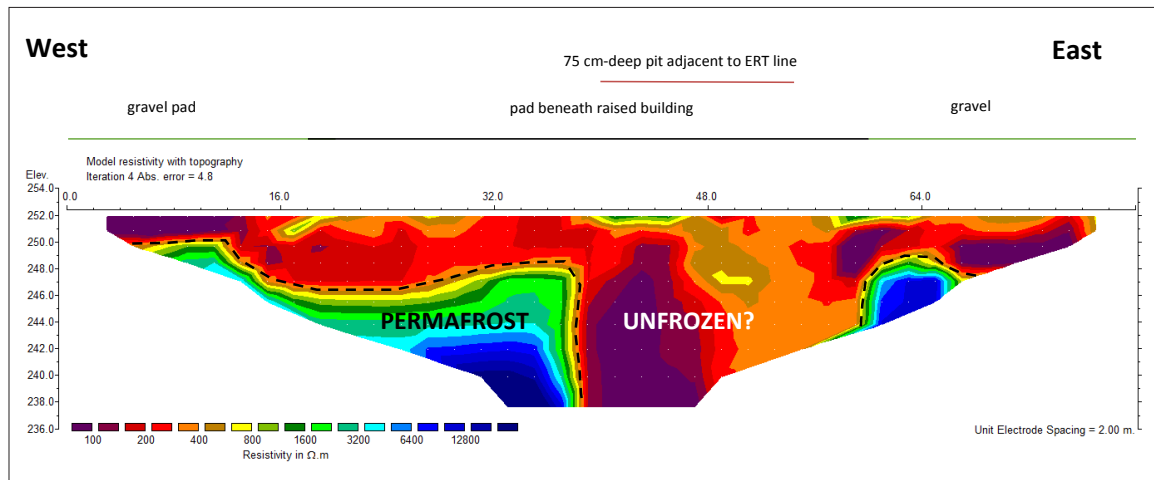
**Figure 54.** ERT profile for Site 1, underneath the John Tizya Centre. The survey is 80 m long and has a maximum penetration depth of about 16 m. Black dashed lines outline likely areas of permafrost.

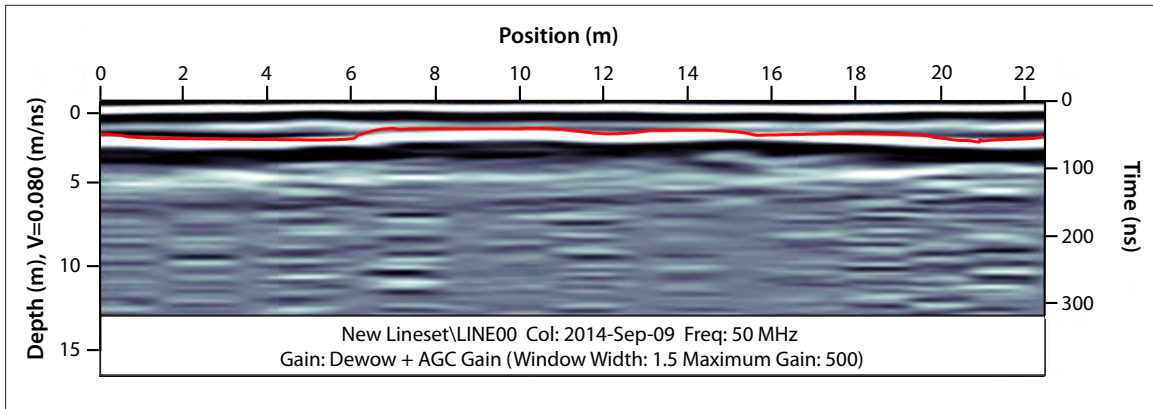
**Figure 56.** GPR profile for Site 2, displayed with an AGC gain (maximum gain of 500) and a velocity of 0.08 m/ns. The red line represents the thaw front.

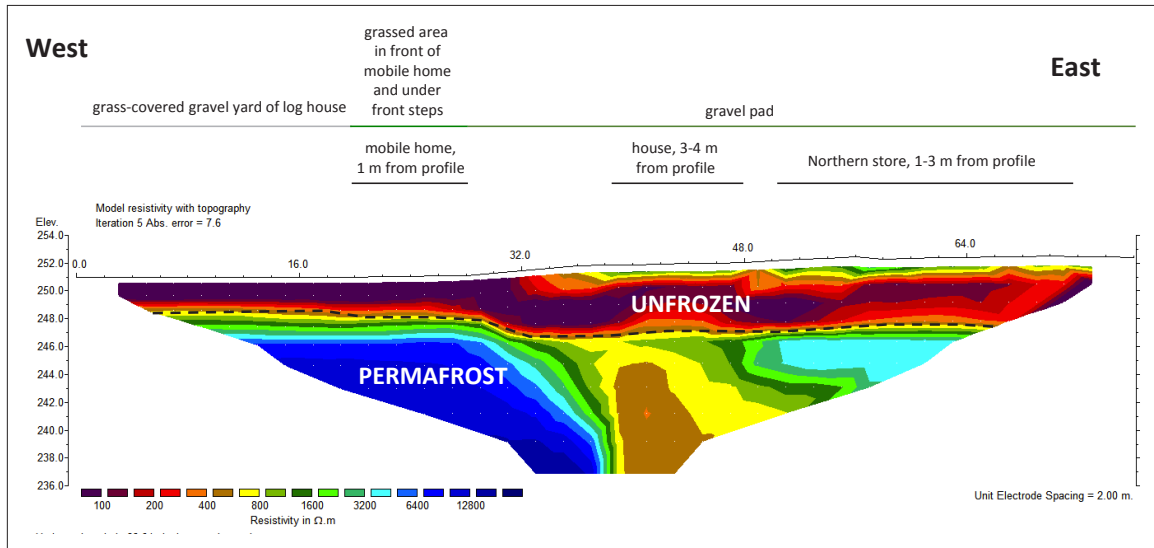
**Figure 57.** ERT profile for Site 3. The survey is 76 m long and has a maximum penetration depth of about 13 m. Black dashed lines outline likely areas of permafrost.

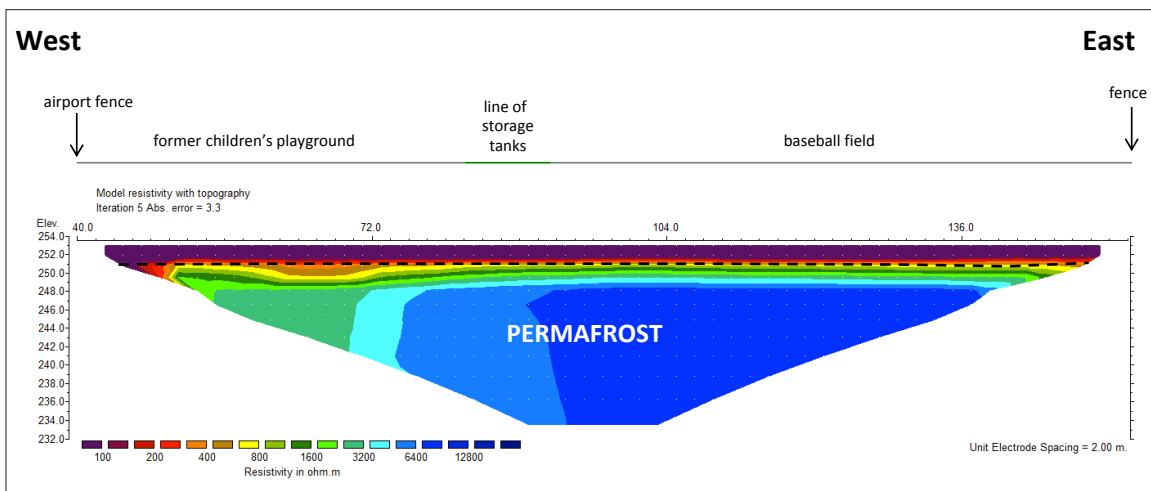
**Figure 60.** ERT profile for Site 5. The survey is 114 m long and has a maximum penetration depth of about 20 m. Black dashed lines outline likely areas of permafrost.

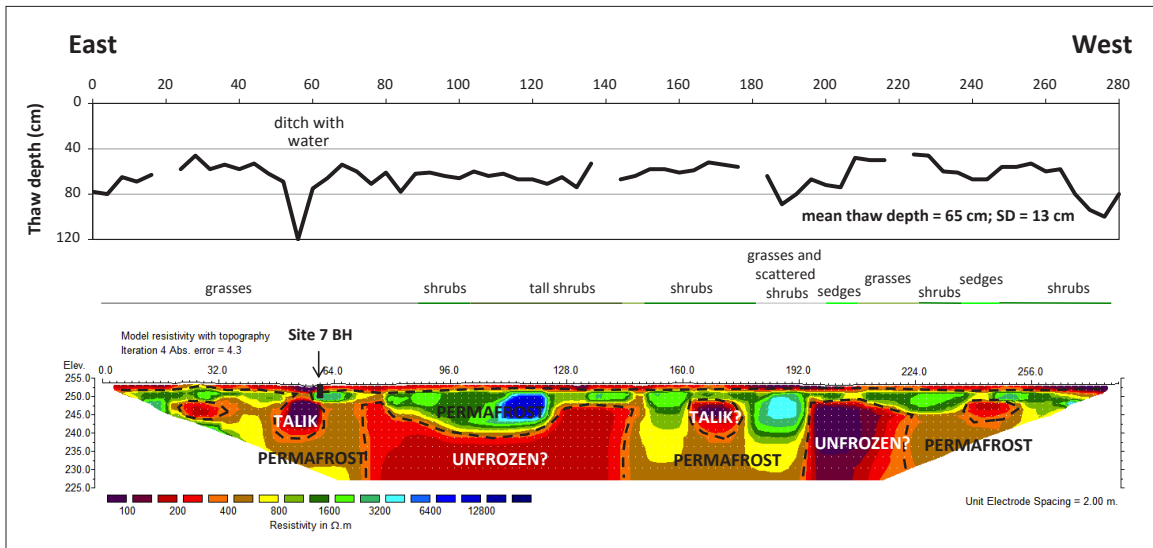
**Figure 65.** ERT profile for Site 7. The survey is 280 m long and has a maximum penetration depth of about 25 m. Black dashed lines outline likely areas of permafrost. SD = standard deviation.

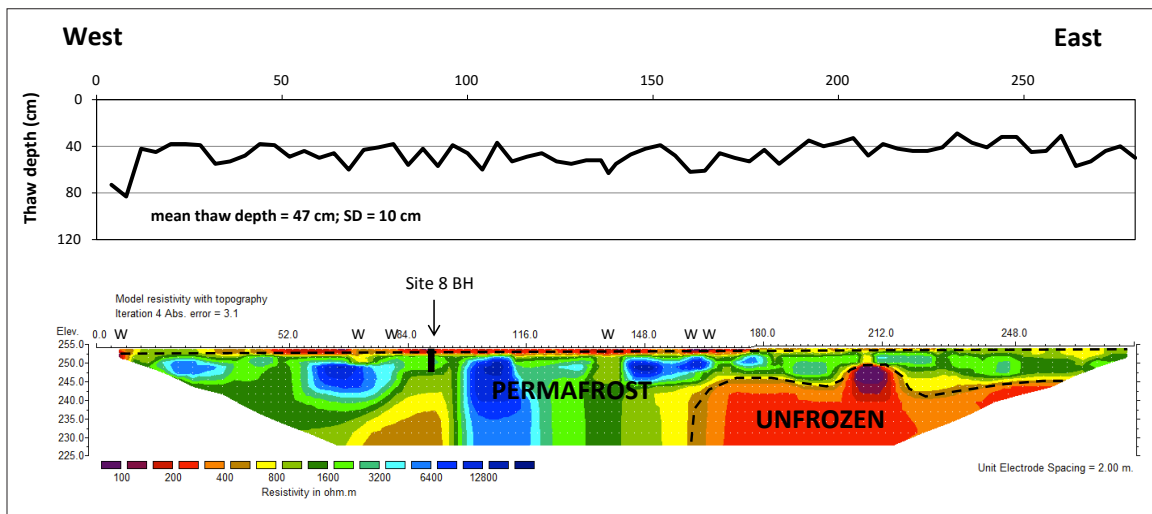
**Figure 67.** ERT profile for Site 8. The survey is 280 m long and has a maximum penetration depth of about 25 m. Black dashed lines outline likely areas of permafrost. W = areas of standing water; SD = standard deviation.

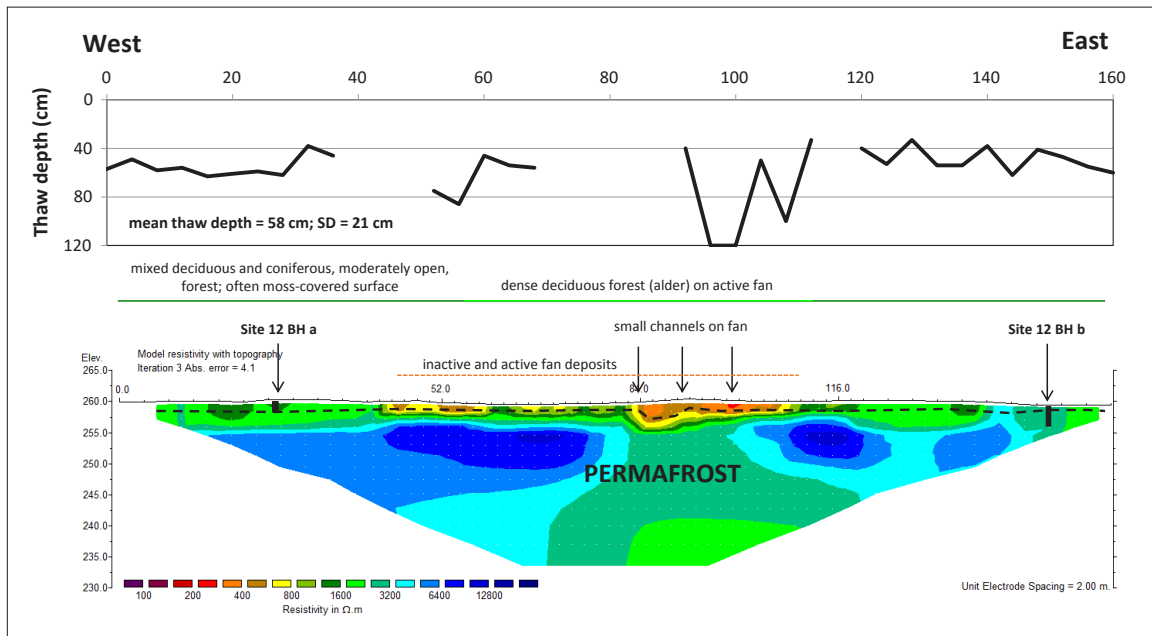
**Figure 73.** ERT profile for Site 12. The survey is 160 m long and has a maximum penetration depth of about 25 m. Black dashed lines outline likely areas of permafrost. SD = standard deviation.

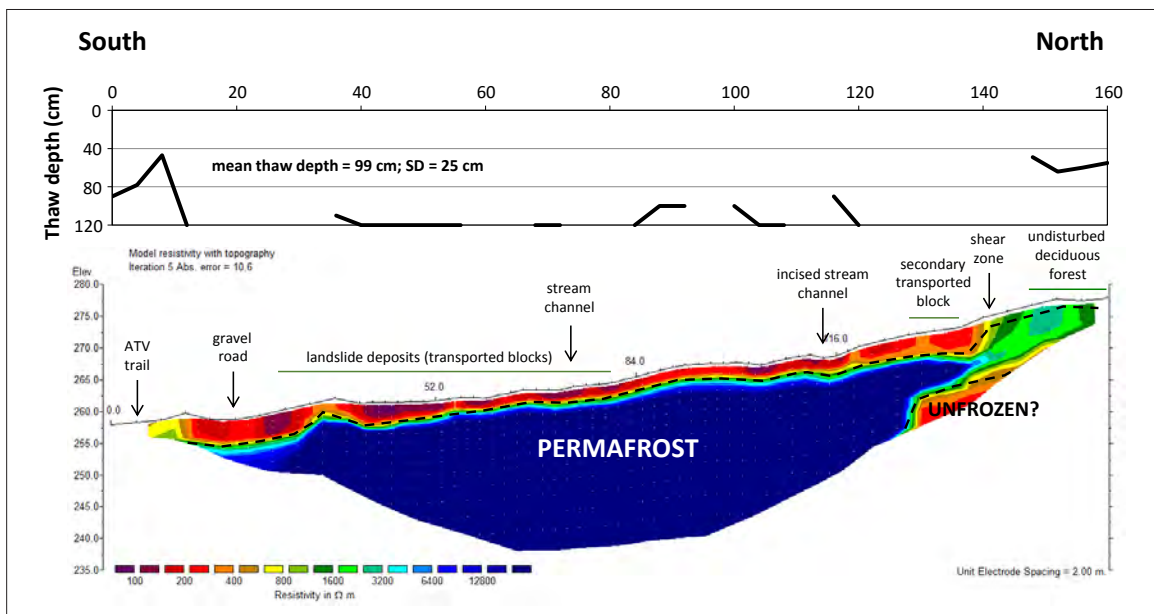
**Figure 77.** ERT profile for Site 14, extending along the track to the toe of a 2010 landslide. The survey is 160 m long and has a maximum penetration depth of about 25 m. Black dashed lines outline likely areas of permafrost. SD = standard deviation.

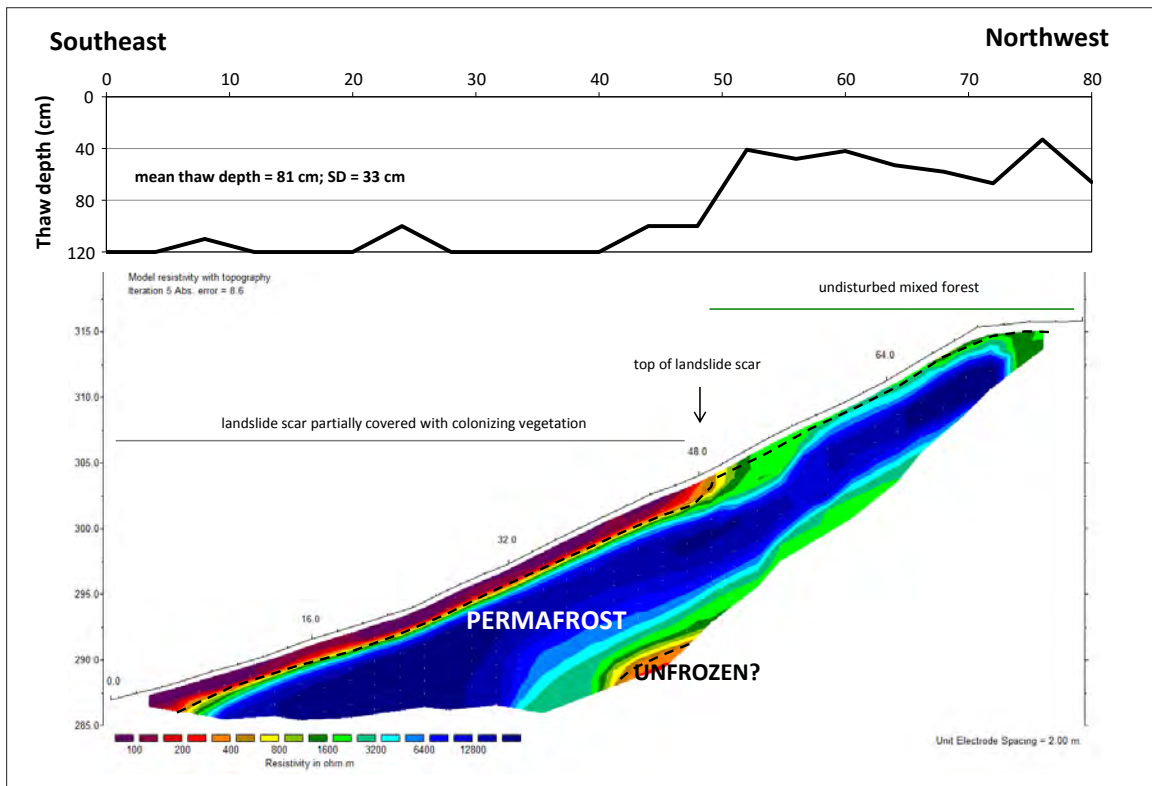
**Figure 78.** ERT profile for Site 14, extending across the upper part of the landslide scar zone and undisturbed terrain. The survey is 80 m long and has a maximum penetration depth of about 16 m. Black dashed lines outline likely areas of permafrost. SD = standard deviation.

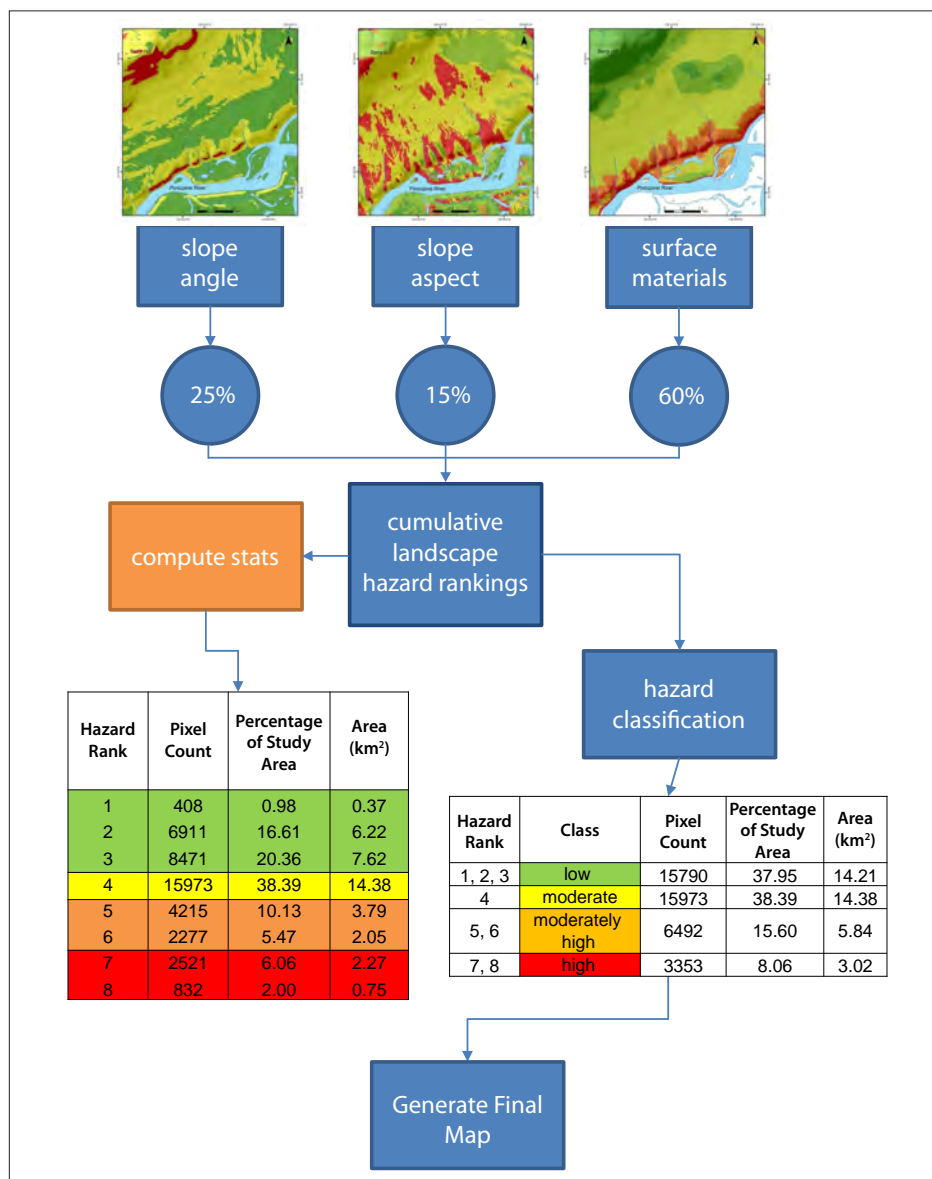
Figure 89. Flowchart illustrating the process used to create the cumulative hazard risk map out of model input parameters for the Old Crow region.

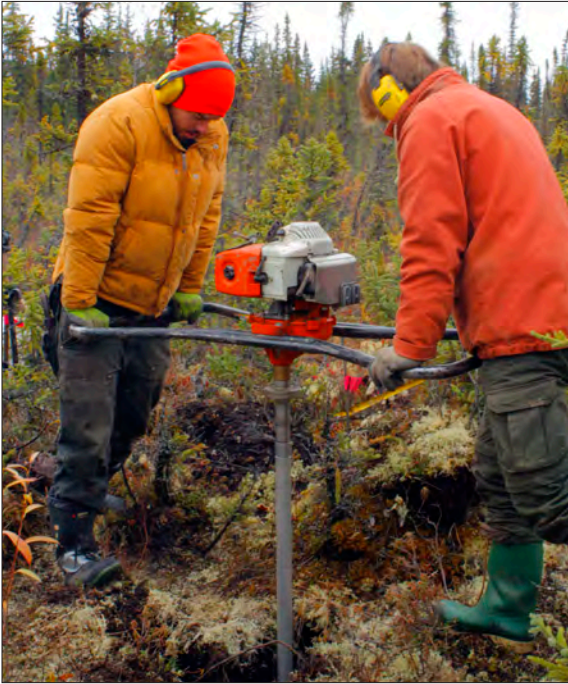
**Figure A1.** Photograph of the GÖLZTM portable core-drill system used for permafrost coring.

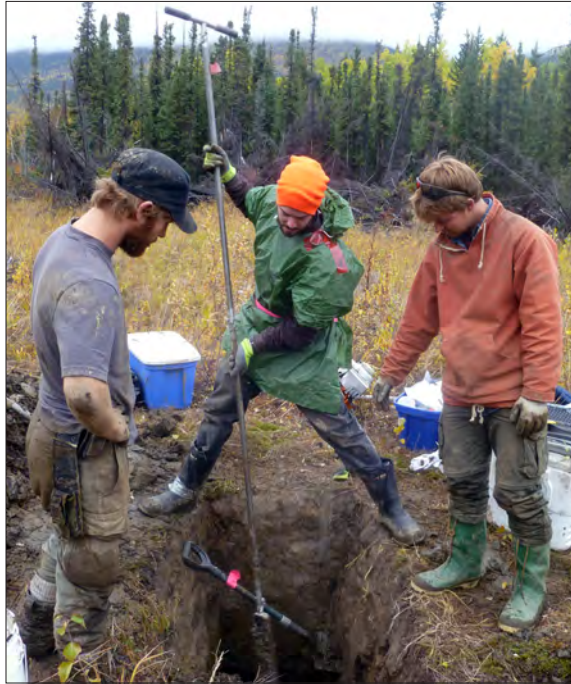
**Figure A2.** Photograph of the hand auger, used for permafrost coring.

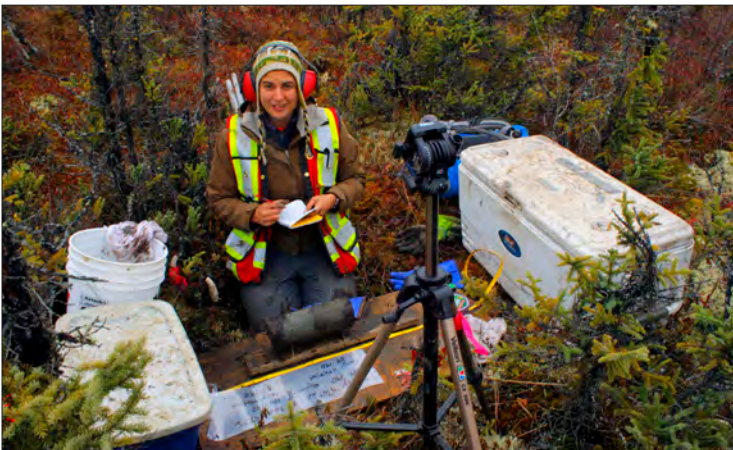
**Figure A3.** Photograph of the setup used for in-field core descriptions.

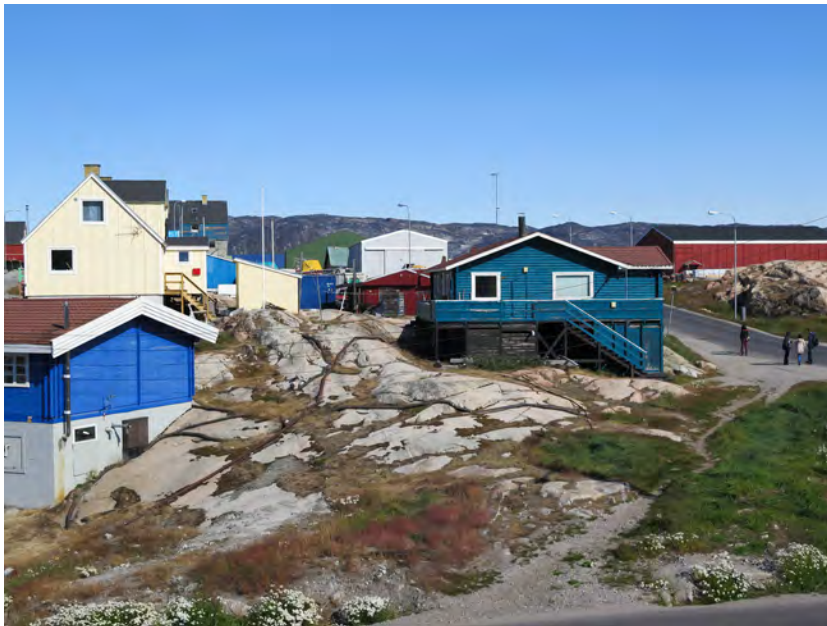
**Figure C1.** Houses in Ilulissat, western Greenland, built directly on bedrock.

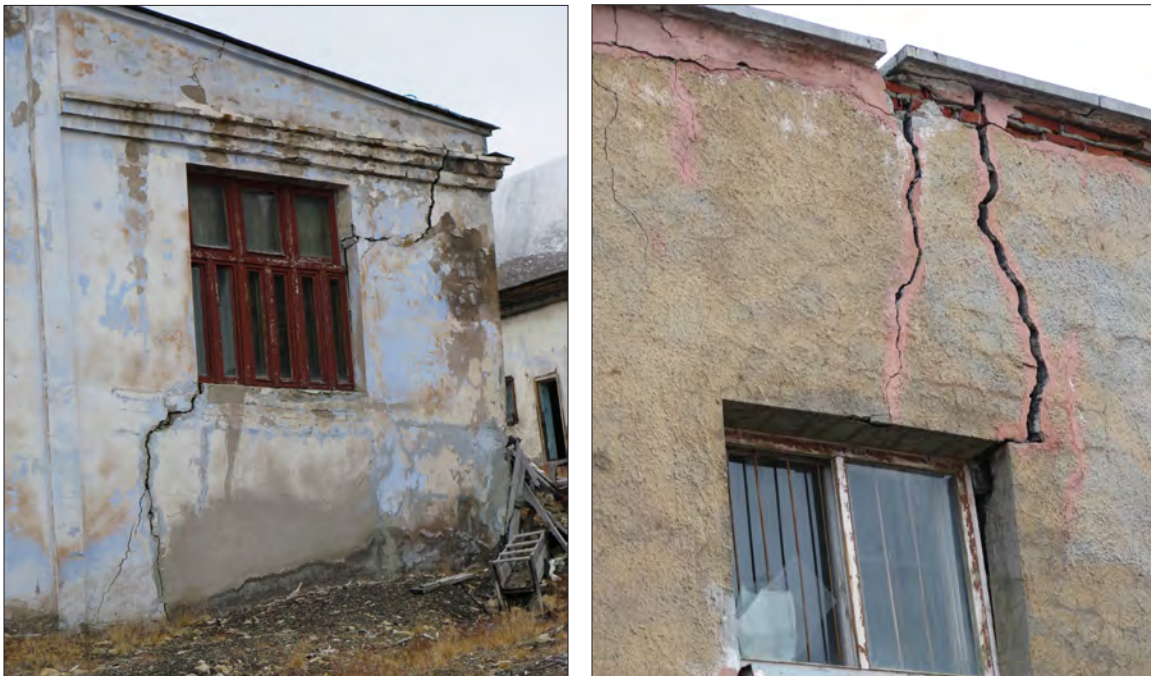
**Figure C3.** Examples of unmaintained buildings in Pyramiden, Svalbard, displaying cracks and uneven settlement in response to permafrost thaw.

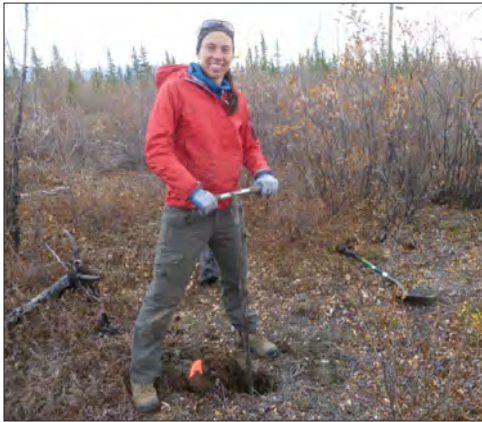
**Figure C5.** Frost-probing to determine depth to permafrost.

When the top of the permafrost is shallow and the active layer is relatively soft, frost probing is an effective method for locating depth to permafrost (Figure C5). This technique uses a steel rod with a handle, which is pushed into the ground manually until the top of the permafrost is reached. With this method, shallow permafrost can easily be detected, and its depth measured. Frost probing is inexpensive, fast and very useful for preliminary site investigations.

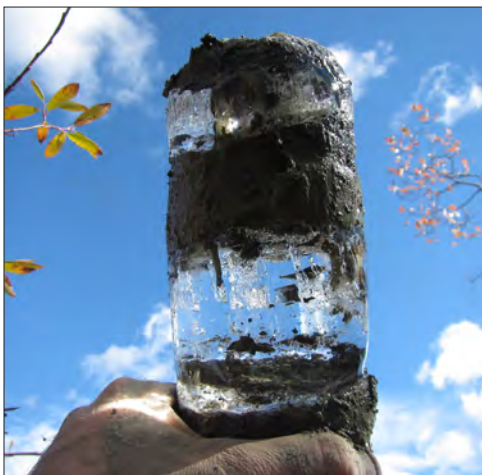
**Figure C6.** Example of ice-rich permafrost core from the Beaver Creek area, Yukon.
