# Old Crow landscape hazards

Geoscience mapping for climate  
change adaptation planning

**Northern Climate ExChange**  
YUKON RESEARCH CENTRE • Yukon College

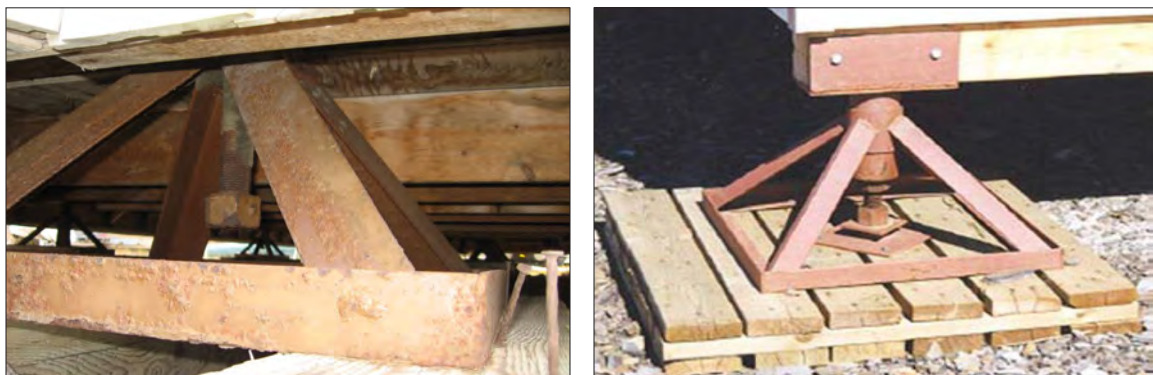
**Figure C11.** Examples of adjustable-jack foundations from Gravel (2012) and CSA (2010).

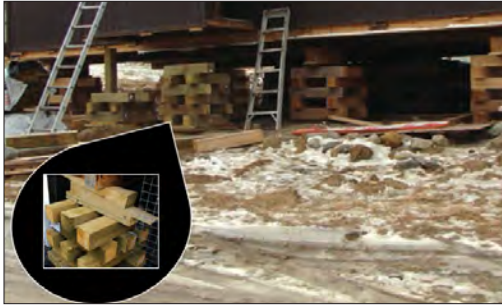
**Figure C12.** Example of a timber-block foundation used in Nunavut (Government of Nunavut, 2013).

Timber-block foundations (Figure C12) work on the same principle as the screw-jack technique. However, screw jacks are not always easily obtainable and it can be more convenient to use timber blocks. Timber blocks are normally screwed together to ensure lateral stability. Timber blocks are commonly sited directly on natural ground (without a gravel pad).

Maintenance operations are almost the same as for screw-jack foundations, described above; however, the operator must use a hydraulic jack to lift the load of the building before shimming the timber blocks. Maintenance for this style of foundation is therefore more labour intensive than for screw-jack foundations.

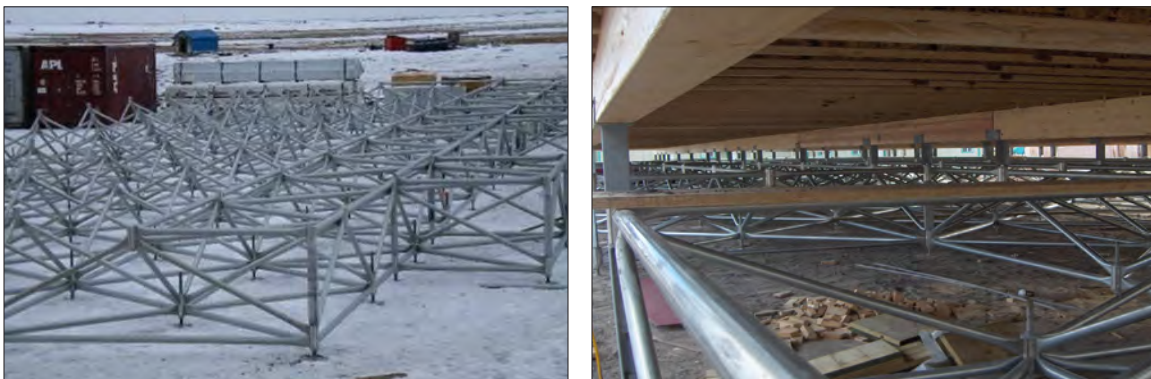
**Figure C13.** Examples of space-frame foundations in Nunavut (Barriault, 2012).

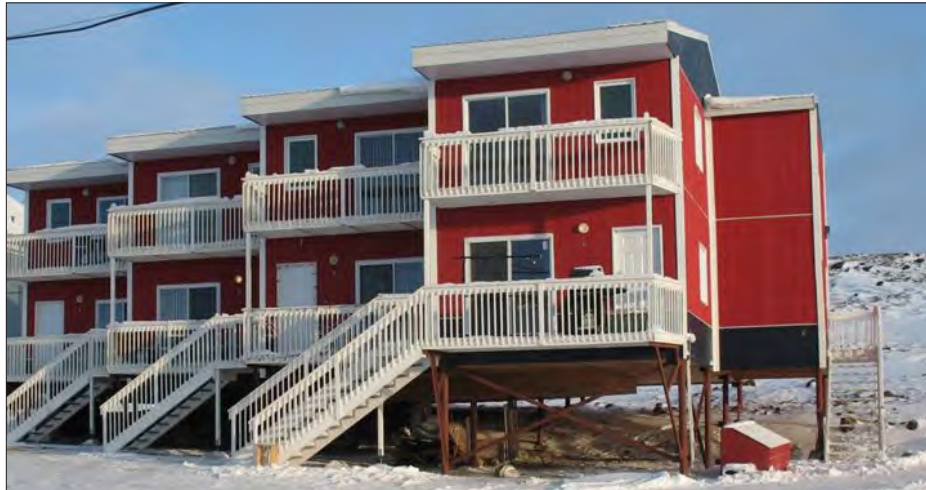
**Figure C14.** Example a steel-pile foundation in Nunavik (Gravel, 2012).

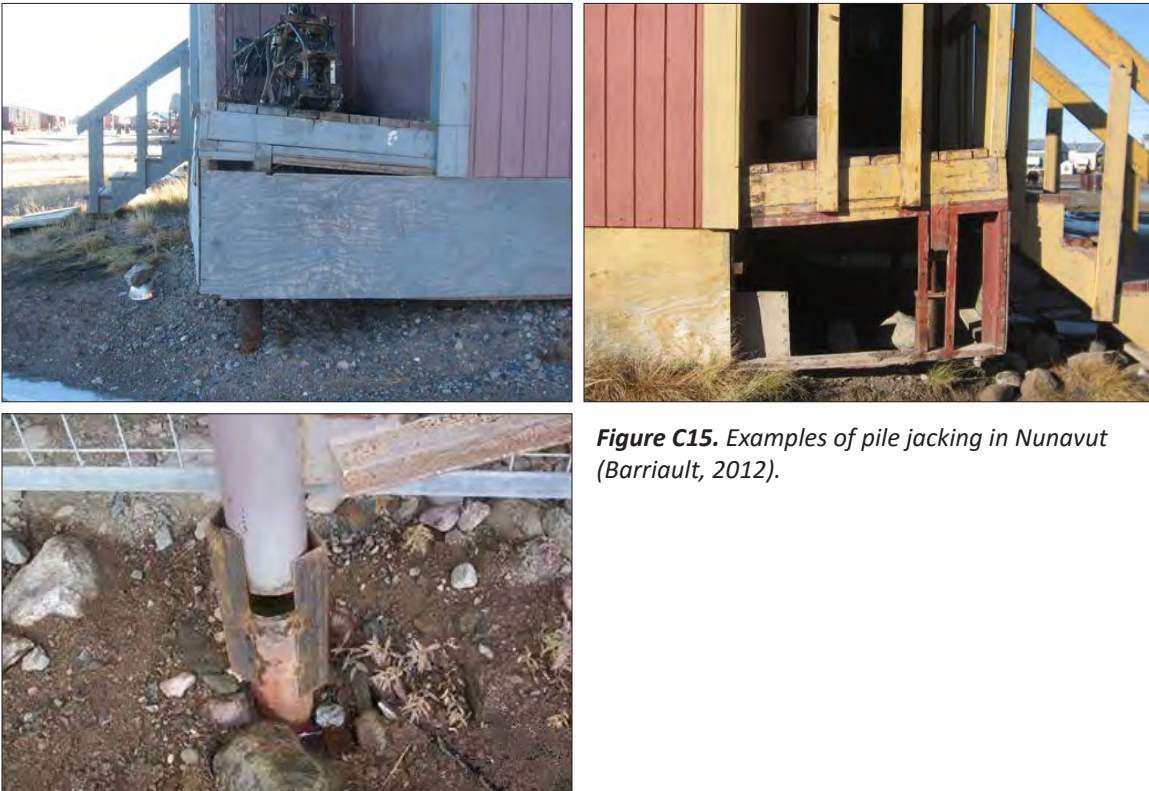
**Figure C15.** Examples of pile jacking in Nunavut (Barriault, 2012).

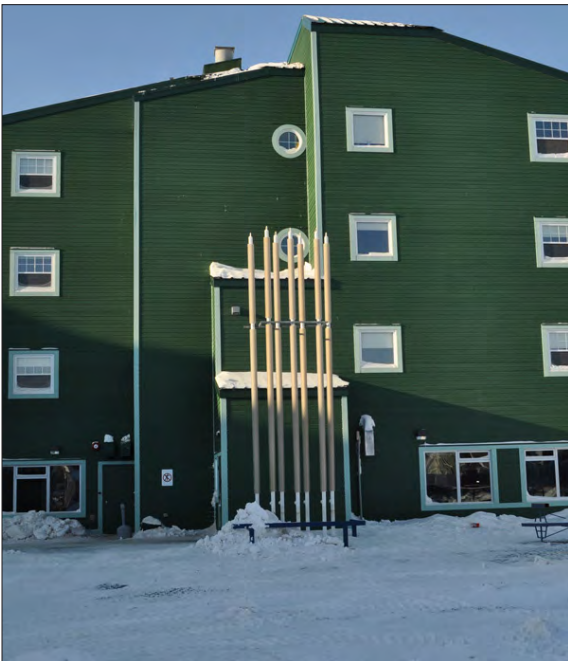
**Figure C16.** Example of thermosyphons, a foundation system that requires a significant amount of expertise to design, install, maintain and monitor (CSA, 2014).

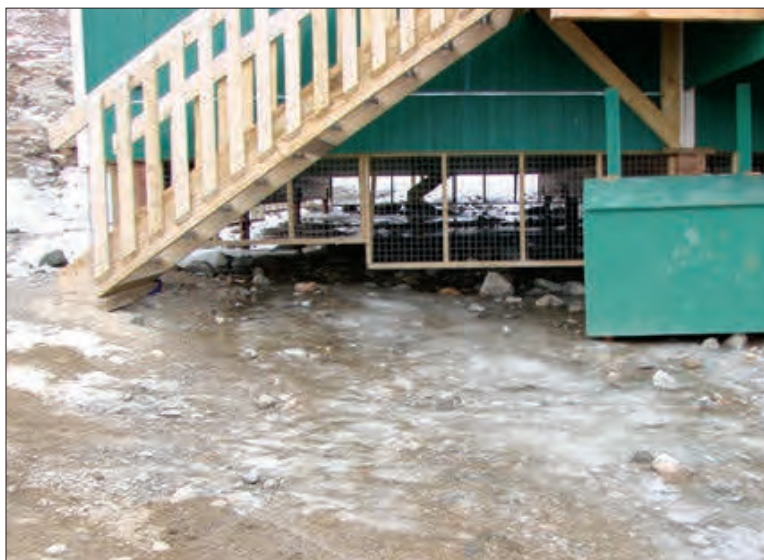
**Figure C18.** Example of water ponding around a foundation built on permafrost (Government of Nunavut, 2013). Water ponding can have a negative impact on permafrost thermal regimes.

Because water transfers heat to the ground and can negatively impact permafrost, ditches should not be excavated in permafrost. Proper surface drainage to avoid water ponding beneath or next to the building is very important (Figure C18), especially with regards to spring meltwater (which can result in a high volume of flow during a short period of time). Slopes of approximately 4% are considered sufficient to drain any water at least 4 m (and preferably 6 m) from a building. Any terrain modification that could alter water paths should be carefully considered.
