Assessment of Risk to Infrastructure from Permafrost Degradation and a Changing Climate, Ross River

Calmels, F., B. Horton, L.P. Roy, P..Lipovsky.and.B. Benkert, 2016. Assessment of Risk to Infrastructure from Permafrost Degradation and a Changing Climate, Ross River. Northern Climate ExChange, Yukon Research Centre, Yukon College.

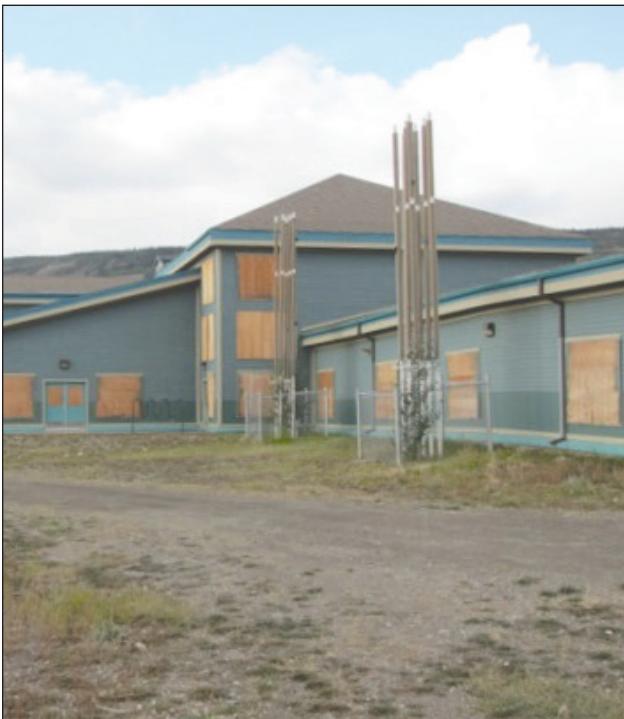
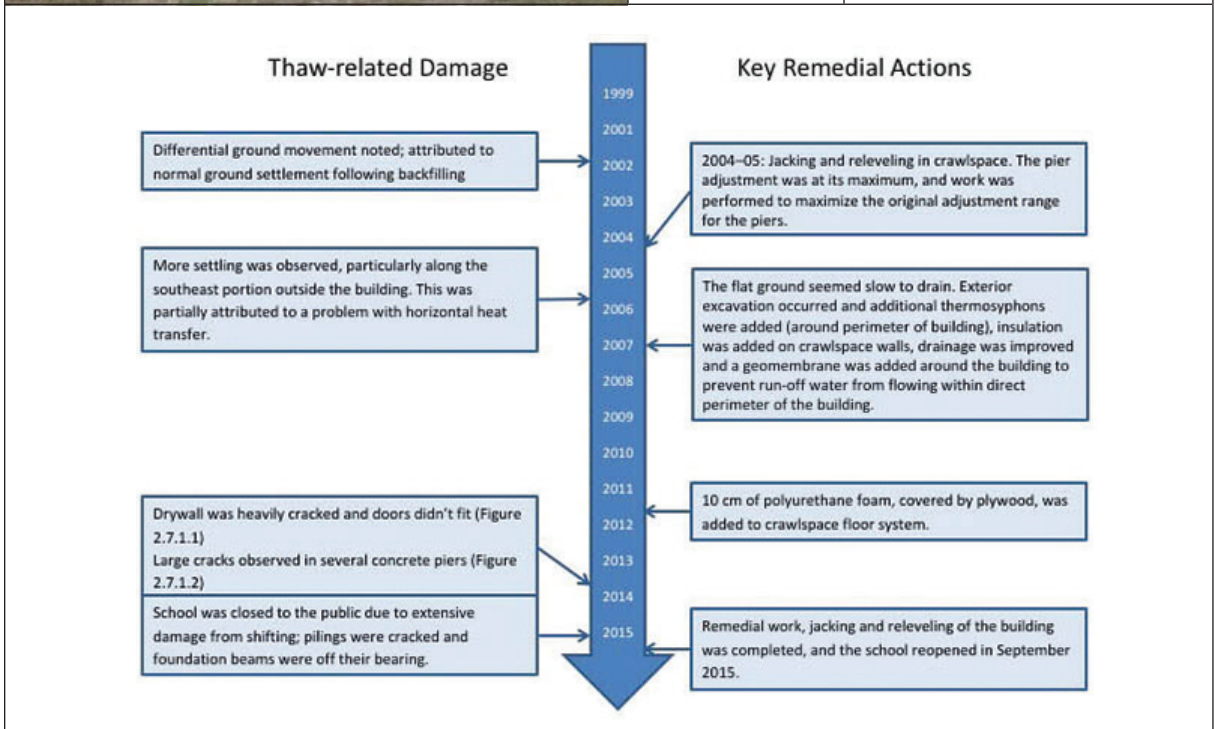
The previous school was located west of the new school, on a lot now vacant between the school and the daycare/community centre. The old school was built in 1972 on a concrete slab at grade foundation with cryo-anchors. It was demolished in 2002. Water leaks from the washrooms caused damage to the structure, and likely affected the permafrost under the building; water pooled towards the middle of the structure.

Figure 2.7.1.1 Damage to drywall in the northeast part of the school

Figure 2.7.1.2 Damage to a concrete pier in the southwest part of the school

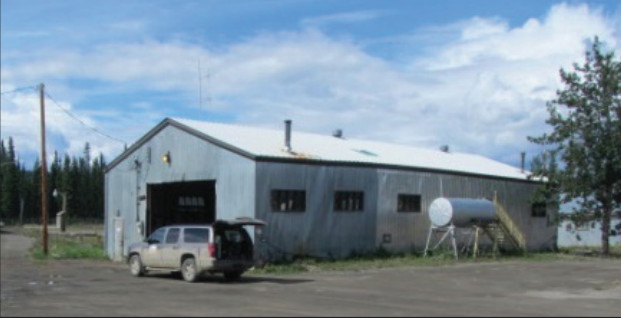
Year completed:	Original building in 1965; addition in 1969
	General site characteristics:	Flat gravel pad; no vegetation; poor drainage from site
	Foundation:	Concrete slab at grade; no cooling
	Use:	Grader maintenance shed
<p>Summary of damage from movement: Differential movement has caused siding to buckle and roofline to bow Substantial cracking in slab</p>		
<p>Site history (if known): No known history</p>

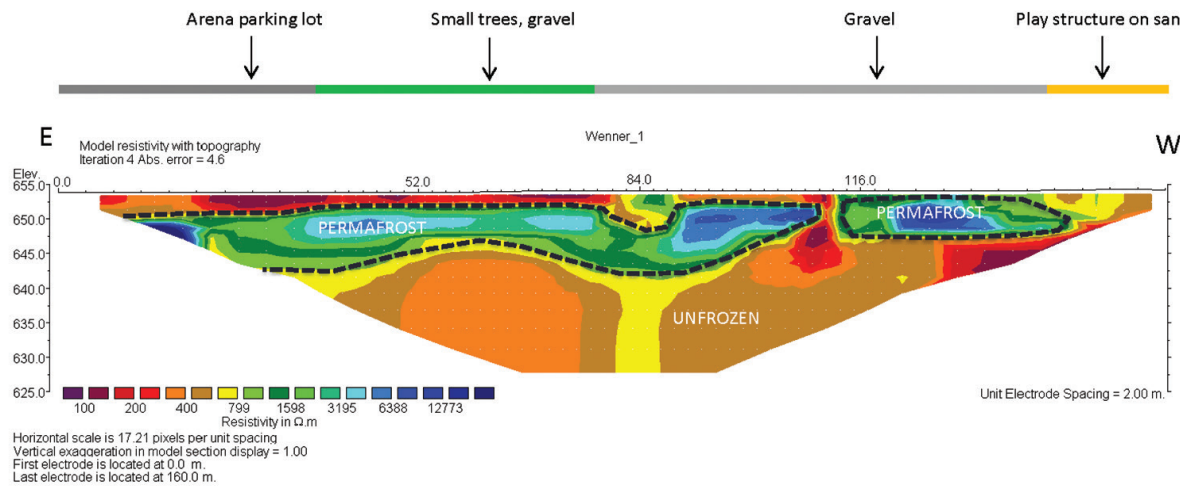
Figure 3.1.2 ERT profile RR_ERT01

Two ERT profiles were completed near the school: RR_ERT01 and RR_ERT02. RR_ERT01 (Figure 3.1.1 and 3.1.2), was 160 m long and oriented east/west from the arena parking lot to the playground structure south of the school. The profile shows a low-resistivity surface layer, inferred to represent an active layer 2 m thick that overlies a layer with higher resistivity (likely permafrost) that extends to depths of 10–12 m.

The base of the permafrost could be located at greater depths than those depicted in the profile. A through-going talik (i.e., unfrozen ground through the permafrost body) was observed from 108–112 m along the profile. Permafrost appears to be present beneath most of the profile, but is thinner to the west and subject to degradation overall.

Location: from the arena parking lot to the playground structure south to the school. Note: The profile has a maximum penetration depth of ~30 m. Likely areas of permafrost are shown as black dashed lines.

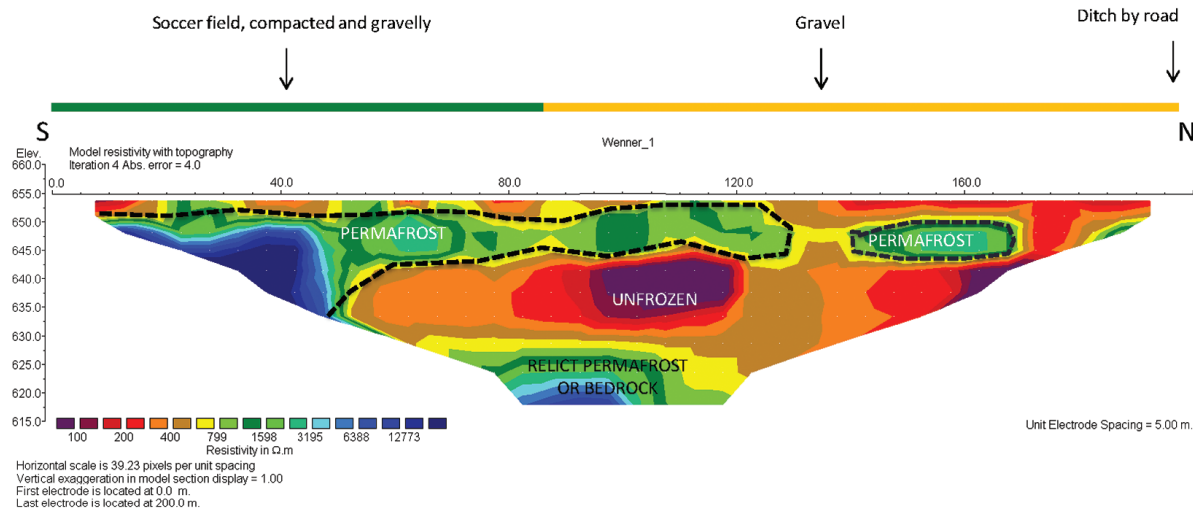
Figure 3.1.3 ERT profile RR_ERT02, on the west side of the school

RR_ERT02 (Figure 3.1.3) was 200 m long and oriented south/north. It was conducted west of the school, from the wooded area to the ditch beside Ross River Road (Figure 3.1.1). The profile is similar to RR_ERT01. It has a discontinuous low-resistivity layer (i.e., active layer) that overlies a higher-resistivity layer (i.e., permafrost), and a second low-resistivity layer that extends towards the base of the profile. However, there is an additional high-resistivity layer in the central part of this profile.

Note: The profile has a maximum penetration depth of ~30 m. Likely areas of permafrost are shown by black dashed lines.

Permafrost is believed to reach depths of up to 20 m at the southern end of the transect, decreasing to less than 10 m at about 80 m along the profile (near the transition to the surface gravel), and possibly disappearing or being overlain by a supra-permafrost talik within 30 m of the road. The high resistivity at depth at the southern end of this profile may represent high ice content or a stratigraphic change. The high resistivity below 30 m in the centre of the profile may indicate deep permafrost that is gradually thawing or a bedrock contact beneath the glaciolacustrine sediments.

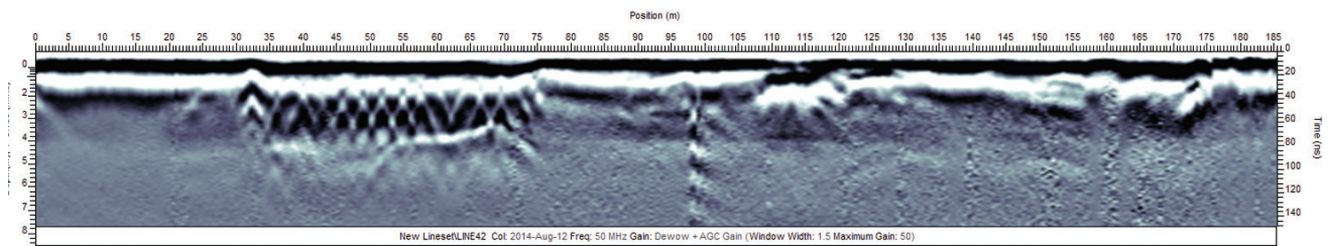
Figure 3.1.4 GPR profile (RR_GPR01) from the field next to the school

Two GPR surveys were performed in the central Ross River area. The first, RR_GPR01 (Figure 3.1.4), was 185 m long and ran parallel to ERT profile RR_ERT02. It was run from north to south. The signal penetrated to a depth of ~4 m. An irregular layer, believed to be the permafrost table, was observed at a depth of ~1.7 m at the beginning of the profile; it got deeper towards the forest, reached a maximum depth of ~3 m, and rose again to a depth of ~2 m under the forest cover.

Note: this illustrates a strong horizontal reflection at ~170 cm that likely corresponds with the top of the permafrost table.

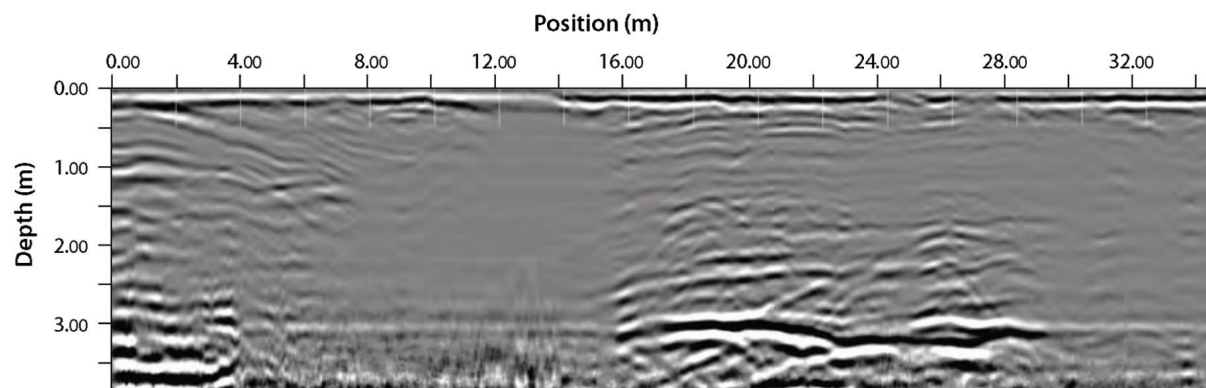
Figure 3.1.5 GPR profile (RR_GPR02) from the field adjacent to the school

The second GPR survey, RR_GPR02 (Figure 3.1.5), was run south-north, parallel to GPR survey RR_GPR01. It depicts the stratigraphic reflection at a depth of ~160 cm, which likely represents the contact between the active layer and permafrost. The hummocky appearance of the layers may correspond to the sand and gravel fill used in the construction of the playing field. This strong reflection could correspond to the change in resistivity visible on the south side of ERT profile RR_ERT02 (Figure 3.1.3).

Note: This runs parallel to GPR survey RR_GPR01 (see Figure 3.1.4), and shows a stratigraphic reflection at 1.6 m that likely corresponds with the top of the permafrost table.

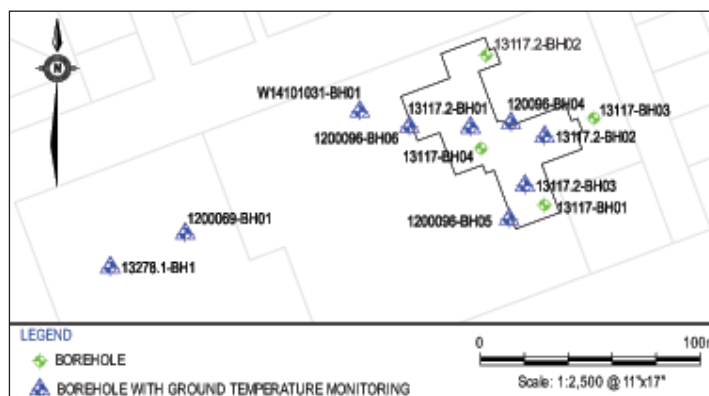
Figure 3.2.1 Location of boreholes in the study area

New development in central Ross River beginning in the late 1990s required several boreholes to be drilled. This work was completed by the private company Tetra Tech EBA between 1998 and the present. Figure 3.2.1 shows the locations of the 13 boreholes that were considered in this study; 9 of them were fitted with thermistor wires to monitor ground temperatures. Table 3.2.1 summarizes soil and permafrost properties observed in these boreholes. Borehole logs for the 9 boreholes with thermistor wires are presented in the Annex (Tetra Tech EBA, unpublished data).

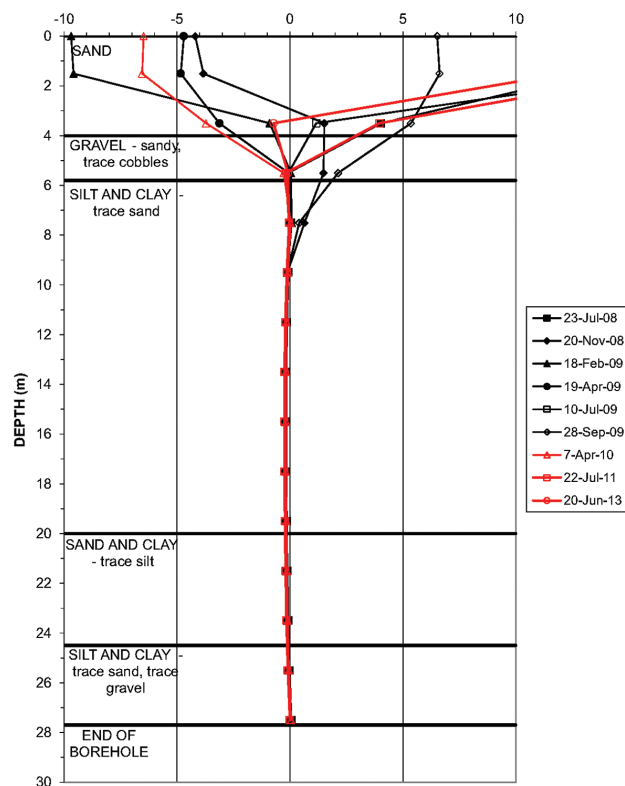
Figure 3.3.1 Ground temperature measurements ($^{\circ}\text{C}$) from the schoolyard borehole

The ground temperature measured at borehole W14101031-BH01, located in the schoolyard west of the school (see Figure 3.2.1), provides the most information about permafrost conditions in the study area. As shown in Figure 3.3.1 and Table 3.3.1, ground temperatures were measured from July 2008 to June 2013. Ground temperatures are presented overlaying the stratigraphy described in the borehole log.

The ground temperature measurements provide two crucial pieces of information. First, the measurements show that the ground is frozen ($T < 0^{\circ}\text{C}$) down to the bottom of the borehole at 27.7 m. This suggests that permafrost is thicker than 20 m and that its base could be as deep as 30 m. Second, permafrost temperature is warm: close to 0°C . This means that only the ice present in the fine glaciolacustrine sediment is preventing permafrost thaw. At this temperature, liquid water content is likely significant and permafrost is very sensitive to degradation.

The active layer appears to have thickened over time, with the top of permafrost deepening from 7.0 m to 9.5 m. These data suggest that permafrost in the study area might be thicker than previously reported. This will affect the magnitude and duration of any subsidence.

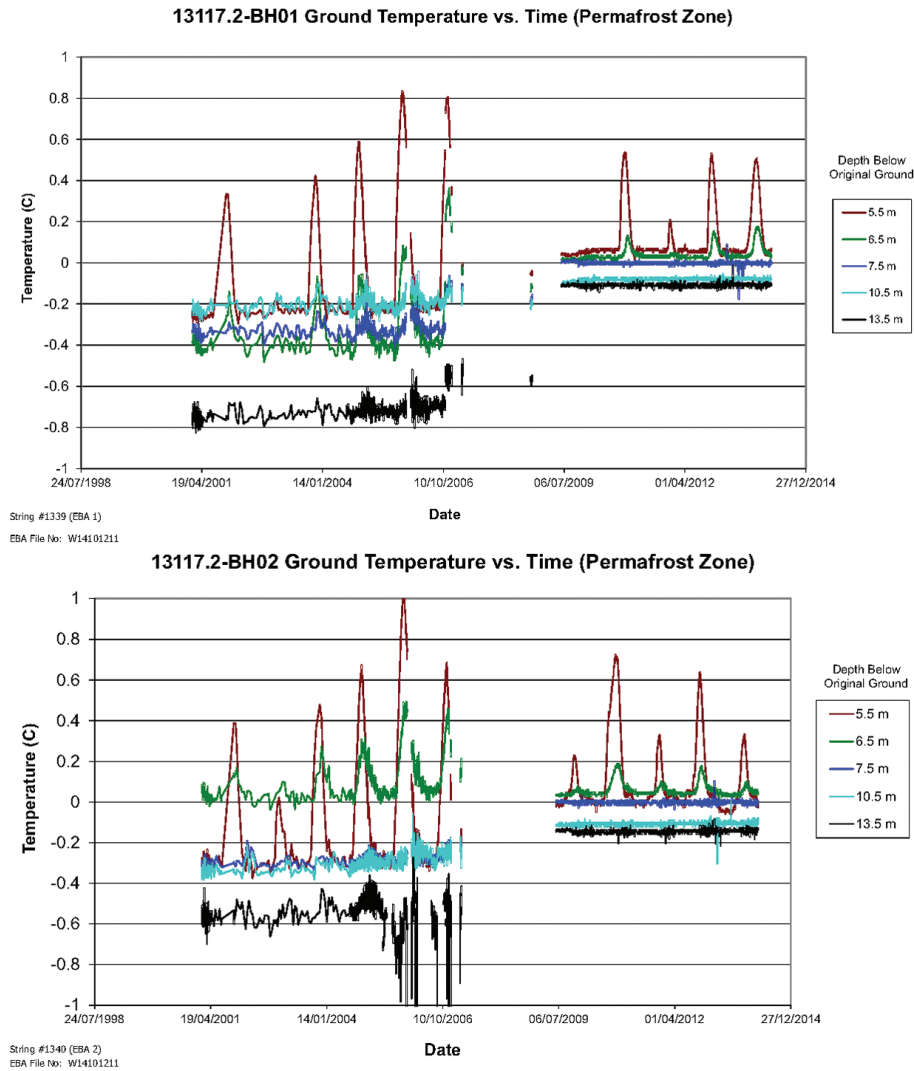
Figure 3.3.2a and b Ground temperatures recorded by Tetra Tech EBA below the school
Source: Boreholes 13117.2-BH01 and 13117.2-BH02

The first group of borehole temperatures (13117.2-BH01 to BH03) is presented in Figures 3.3.2a and b and 3.3.3a. The records show that the deepest temperatures, at 13.5 m, have increased between 0.5 and 0.6°C. These temperatures are now close to -0.1°C. It is revealing that while the early permafrost temperature curves showed fluctuations, more recent curves are almost flat and have no fluctuation. This indicates that permafrost is close to thawing. Typically, the freezing and thawing of the liquid water content prevent seasonal temperature fluctuation, but this is not occurring in these boreholes. Consequently, permafrost as deep as 13.5 m is close to thawing.

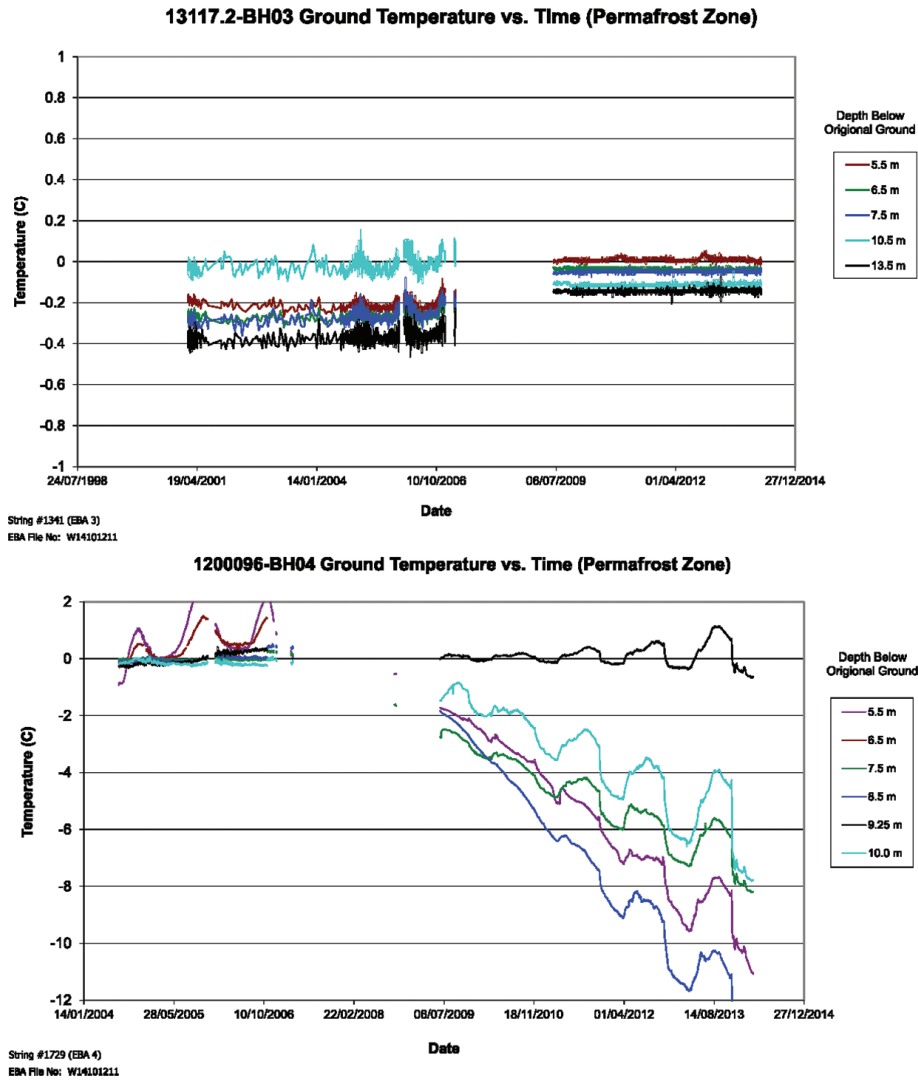
Figure 3.3.3a and b Ground temperatures recorded by Tetra Tech EBA below the school
Source Boreholes 13117.2-BH03 and 1200096-BH04

The second group of borehole temperatures (1200096-BH04 to BH06) is presented in Figures 3.3.3b and 3.3.4a and b. These are more problematic to interpret: although the data recorded from 2004–08 seems rational, the data from 2009–14 seems questionable. The data from 2004–08 shows very warm permafrost temperatures — close to 0°C — in the three boreholes.

We hypothesize two possible explanations for the inconsistencies: 1) the depths may not be labelled properly in the logger program, since Figures 3.3.3b and 3.3.4a and b show cooling trends at all sensors, but at random depths; or 2) because all three boreholes show unrealistically cold temperature, there may be other issues with the setup. The resistors in the thermistors may be faulty, or the conversion of resistance to temperature may have errors.

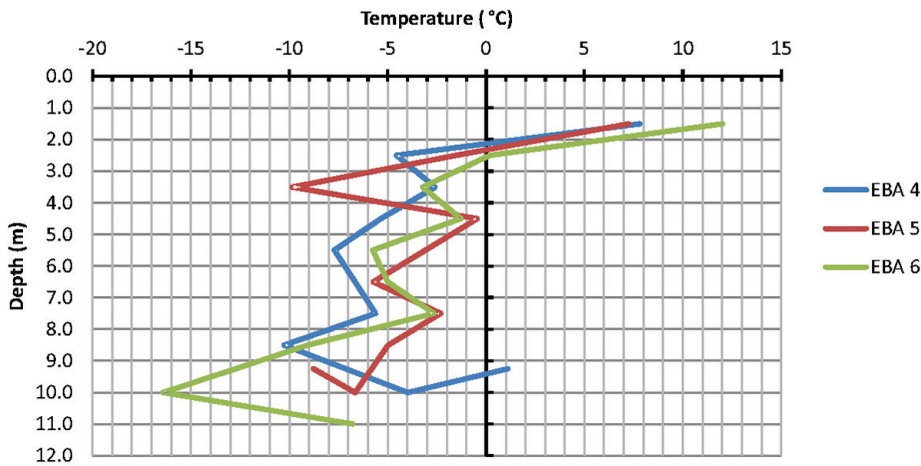
Figure 3.3.5 Ground temperature curves for wires EBA 4, 5 and 6 in 1200096-BH04, -BH05, and -BH06
Location: near the school, August 13, 2013

In 2009, after a period of inactivity, the thermistor wires were connected to new data loggers. Between 2009 and 2014, the data curves show an unrealistic cooling trend. To better understand this, the temperature record from a single day (August 13, 2013) was plotted in a graph showing temperature vs. depth (Figure 3.3.5).

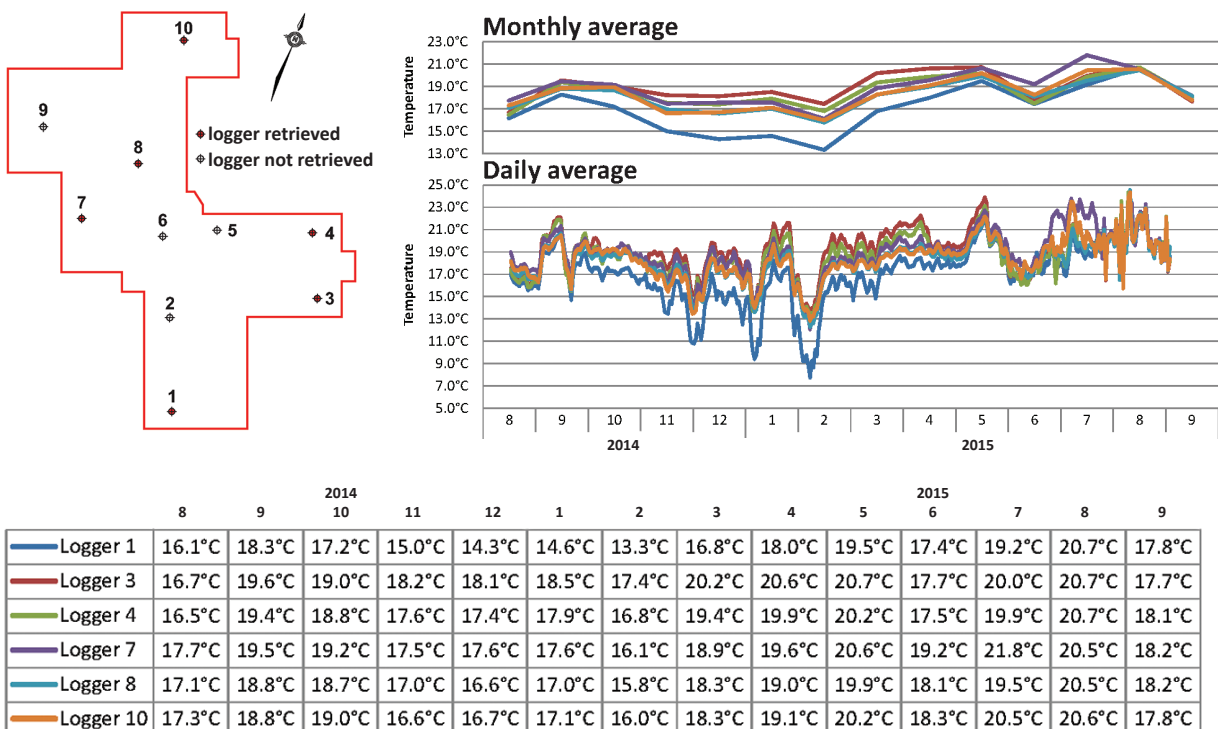
Figure 3.3.6 Temperature recorded at ground surface level in the crawlspace of the school

As described above, pendant loggers were placed on the floor of the school crawlspace. Figure 3.3.6 shows the location of the loggers and plots of the recorded temperatures. Logger 1 recorded the coldest temperatures, varying between 13.3 and 20.7°C during the period of the survey (about one year); other loggers show temperatures that vary between 16.0 and 20.7°C. The overall average of the air temperature at the floor surface during the period of the survey is 18.4°C. Temperatures this high are likely to disturb the underlying ground thermal regime.

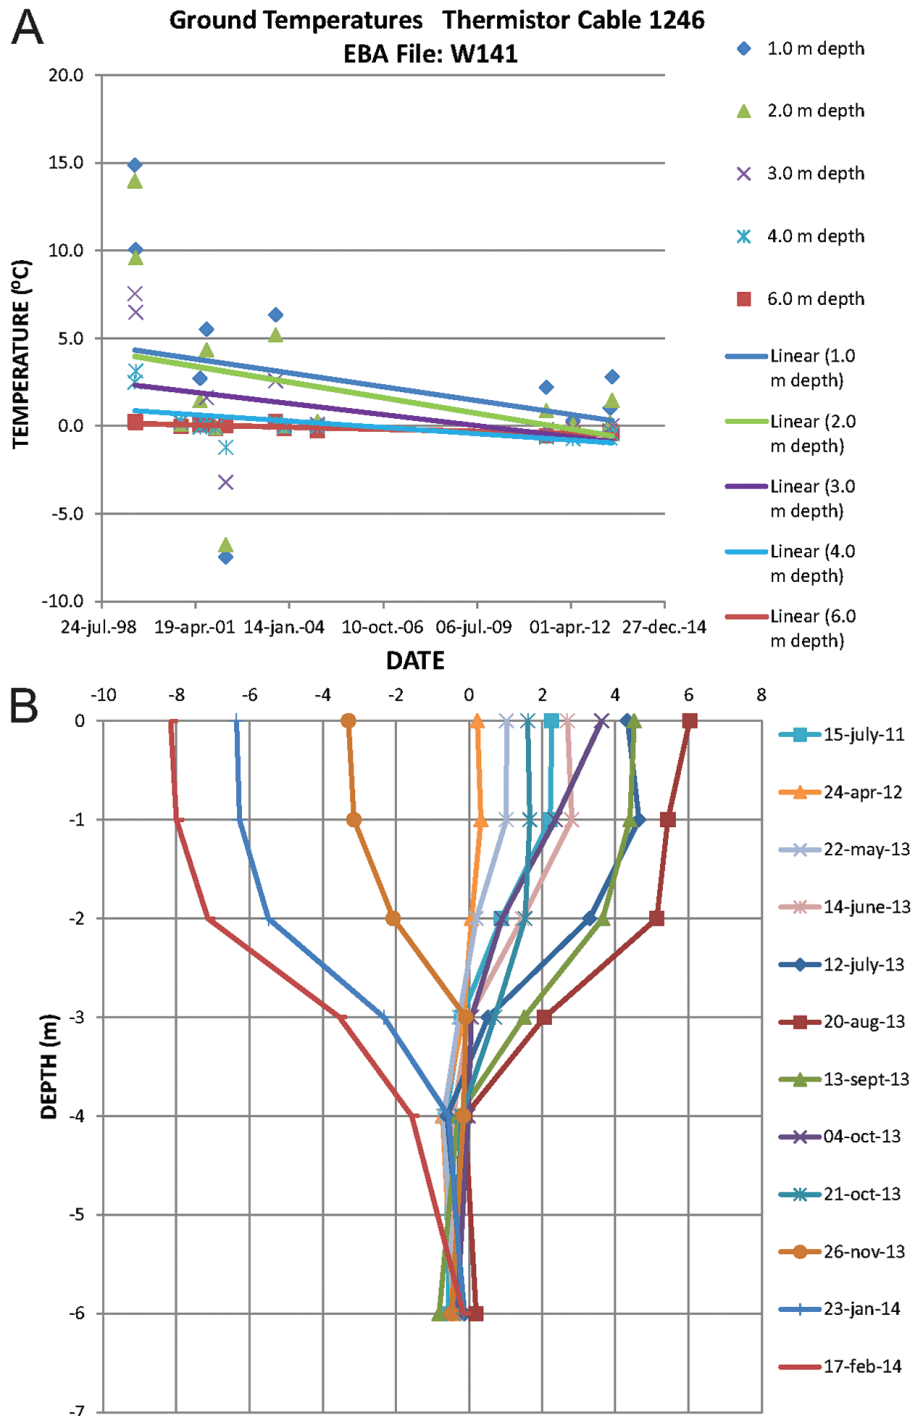
Figure 3.3.7a and b Ground temperature recorded at various times by Tetra Tech EBA under the pool

The thermistor wire below the pool measures ground temperatures to a depth of 6 m. Figure 3.3.7a and b shows the ground temperatures that were manually measured using a multimeter at various times between July 1998 to February 2014.

Figure 3.3.7a shows a trend of cooling from 1998 to 2014; Figure 3.3.7b shows that the deepest temperature (at 6 m) has warmed steadily over time.

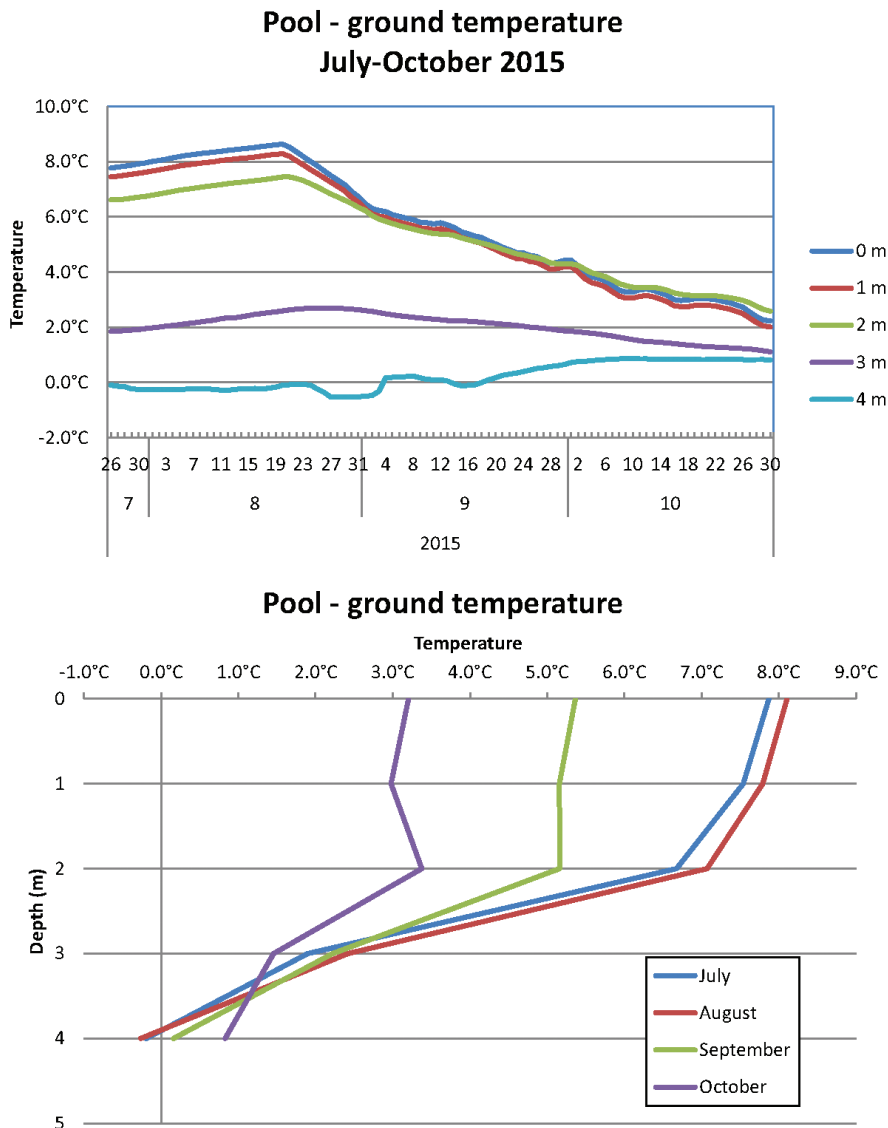
Figure 3.3.8a and b Ground temperature below the pool, July–October 2015

More recent data, acquired by means of a newly installed CR1000 logger from July to October 2015, are shown in Figure 3.3.8a and b. This shows that the ground is unfrozen down to 4 m deep. A bad connection with the logger prevented the temperature at 6 m from being recorded, but the curves suggest that the ground was likely unfrozen at 6 m in October.

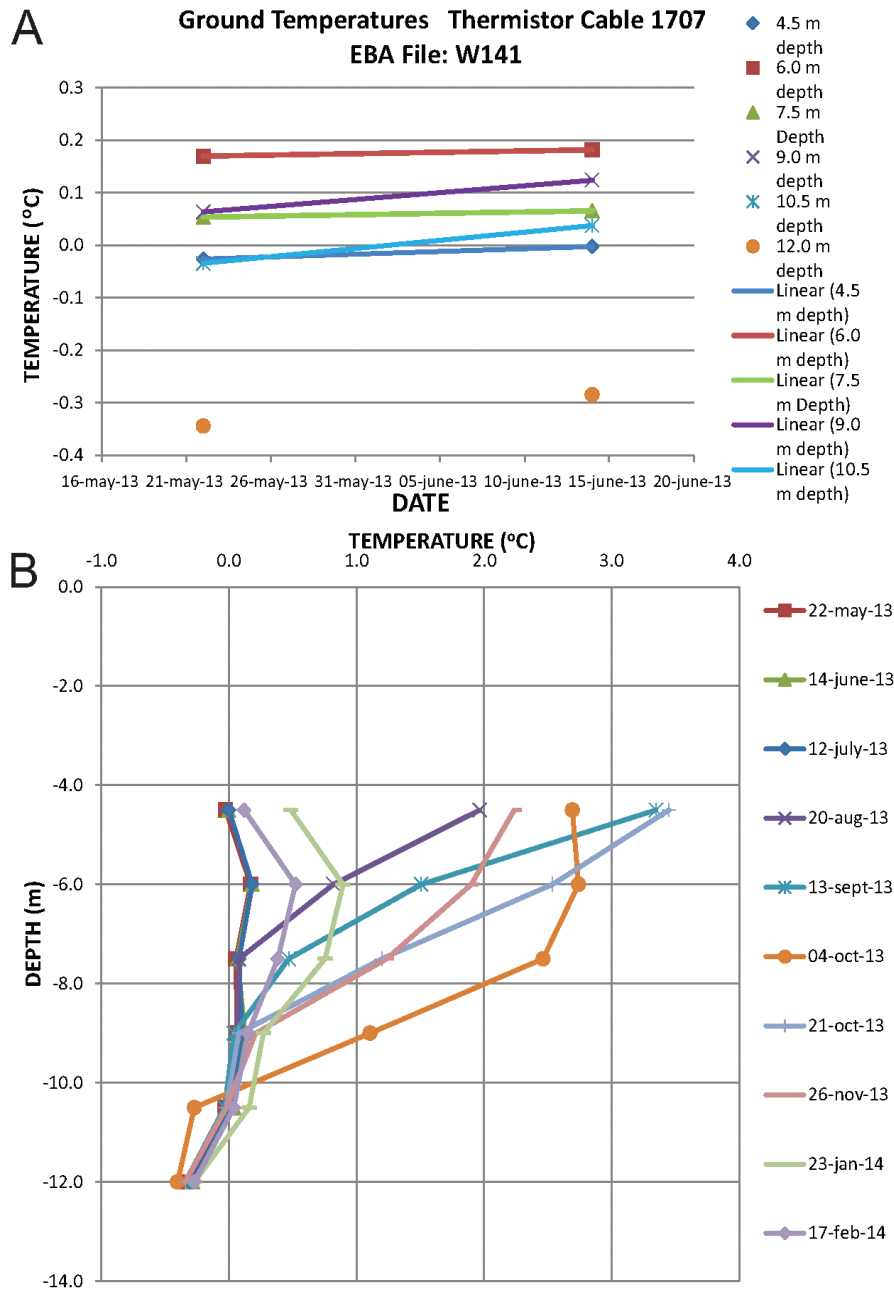
Figure 3.3.9a and b Ground temperature recorded at various times by Tetra Tech EBA
Location: the yard south of the Community Centre

The thermistor wire located in the yard south of the community centre measures ground temperatures down to the depth of 12 m. Figure 3.3.9 shows the ground temperatures that were manually measured using a multimeter at various times between May 2013 to February 2014. Both Figure 3.3.9a and Figure 3.3.9b show a warming trend. The record shows that the permafrost table has moved down to a depth of 10.5 m.

At the deepest sensor (12 m) the temperature is -0.3°C , but has steadily warmed over time. More recent data, acquired by means of a newly installed CR1000 logger from July to October 2015, are shown in Figure 3.3.10a and b. The figure shows that the ground is frozen down to 12 m depth. Water condensation on the logger made the temperature reading unstable.

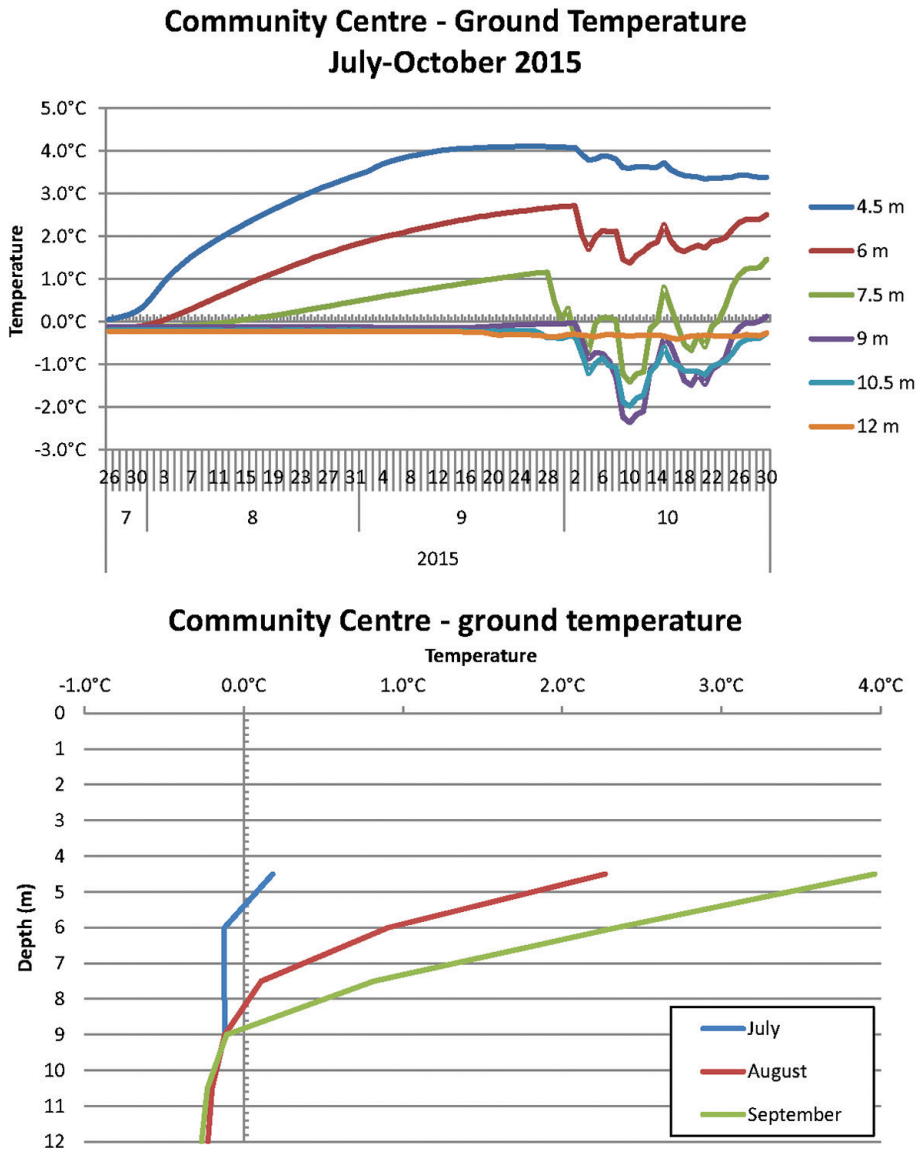
Figure 3.3.10a and b Ground temperature recorded July–October 2015

Location: the yard south of the Community Centre. Note: In Figure 2.2.10b, data was not collected for all of October, so no monthly mean is provided.

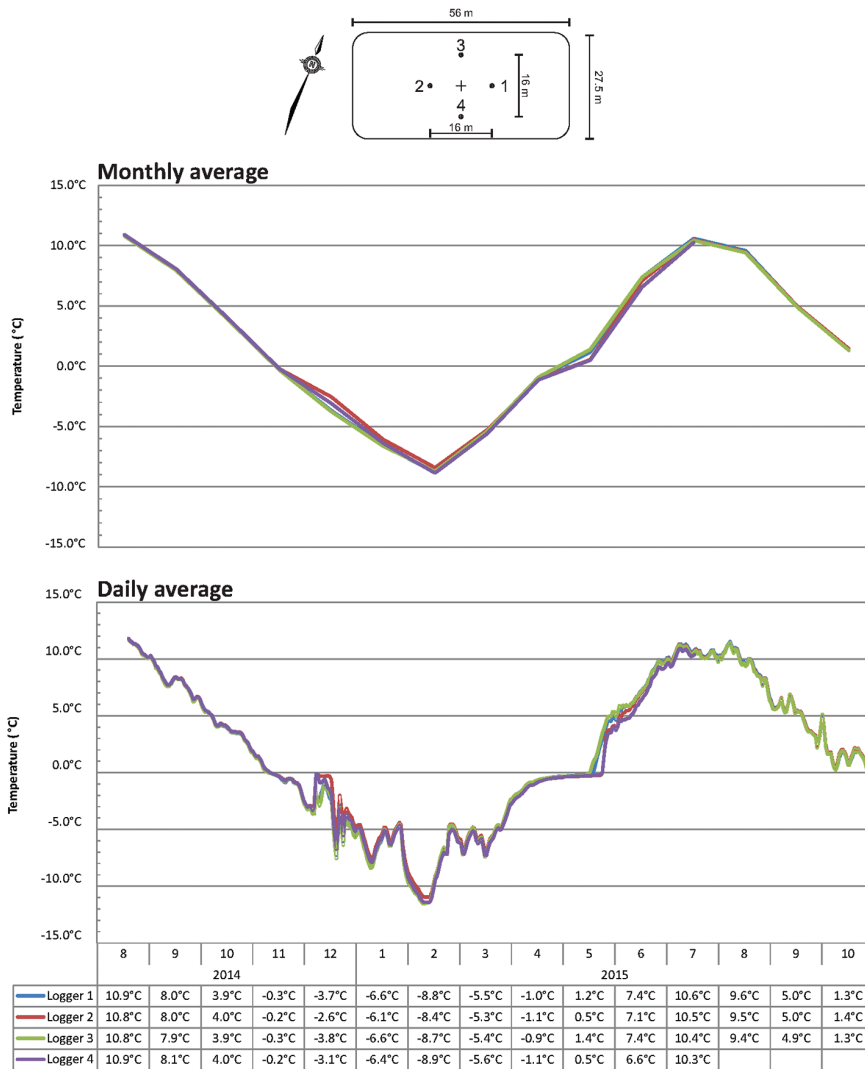
Figure 3.3.11 Temperatures recorded in the ice rink area of the arena, 15 cm below the ground surface
 Note: Locations of the loggers are shown in the upper part of the figure

The location and temperatures recorded by four U12 loggers buried 15 cm in the gravel below the arena are shown in Figure 3.3.11. The four records show the same temperature trend, demonstrating that the icing and thaw of the ice in the arena is the same everywhere in the ice rink

area. The mean annual temperature 15 cm below the ground surface is 1.2° C (from August 2014 to October 2015). These temperatures are well above 0°C and confirm that the arena ice prevents permafrost cooling. Permafrost is currently degrading below the arena.

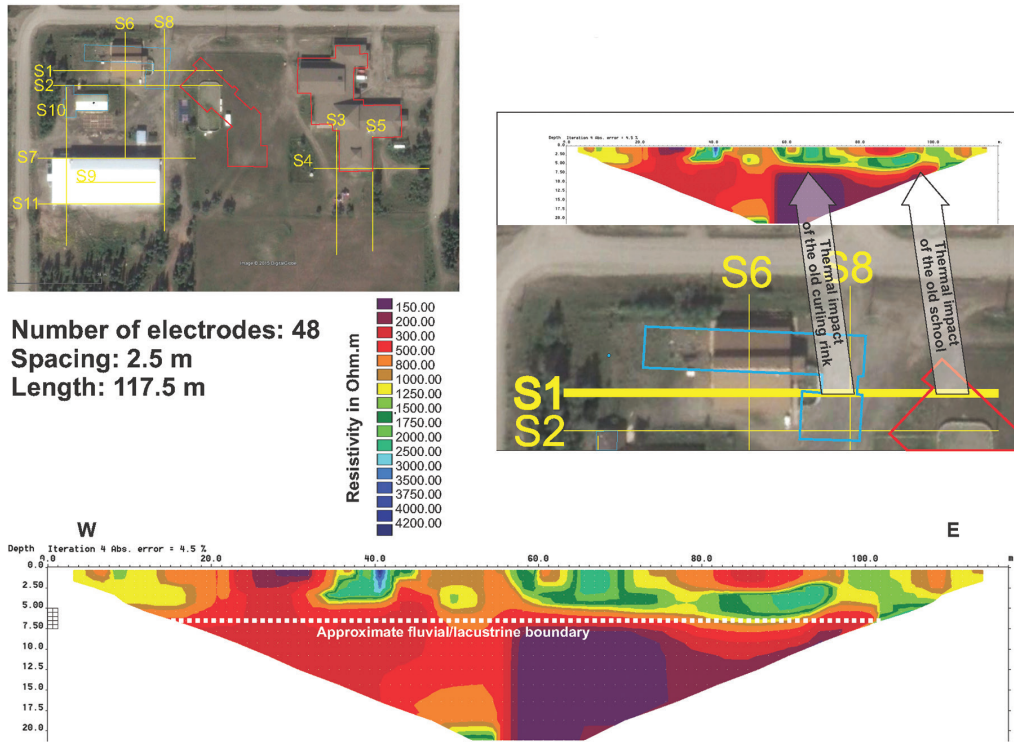
Figure 3.4.1 ERT survey S1, made under the community centre/daycare; oriented west/east

There are limited data, but based on evidence from other buildings in similar conditions elsewhere in the north, it is likely that permafrost warming was induced by the former buildings. This warming has resulted in an increase of liquid water content in the ice-rich glaciolacustrine silt.

Although this ground is frozen, the presence of liquid water has significantly decreased electrical resistivity at the location of the former buildings. At this site, frozen ice-rich silt may be less resistive than unfrozen alluvial gravel (which is unusual). These results raise the possibility that damage to the daycare is the result of ongoing thermal impacts from the former curling rink.

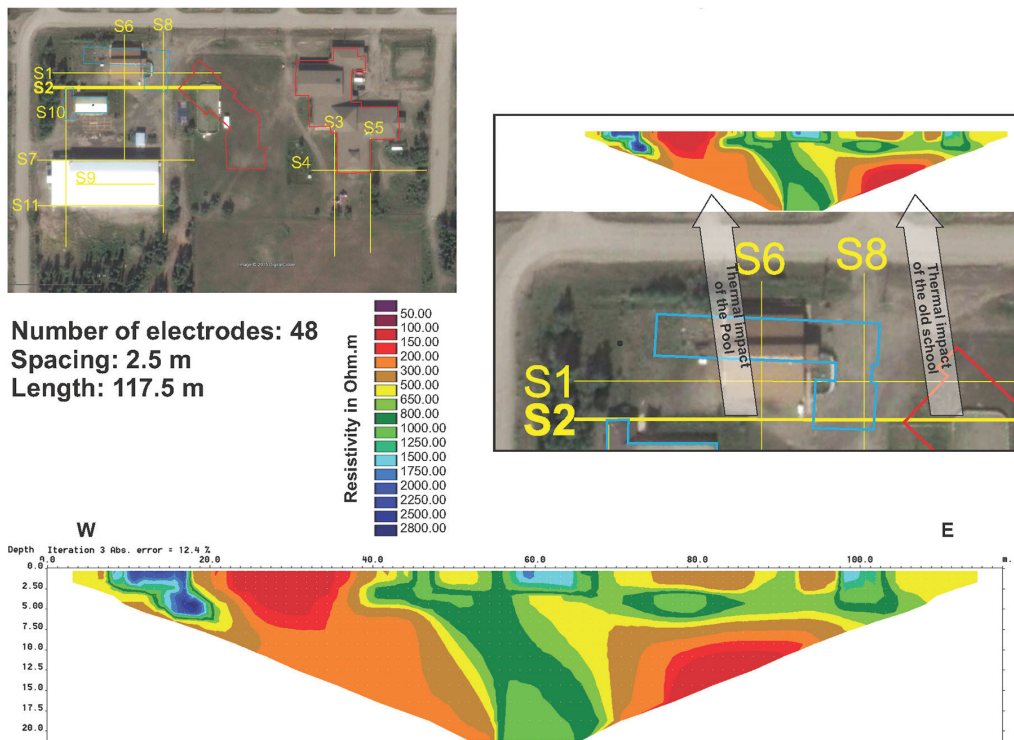
Figure 3.4.2 ERT survey S2, made south of the community centre, oriented west/east

Survey S2 (Figure 3.4.2) was made south of the community centre, and was oriented west/east. Low resistivity areas were detected between 20 to 40 m and between 80 m and the end of the survey line. The first area may be attributed to the reported leak of the pool. The second area coincides approximately with the location of the former school.

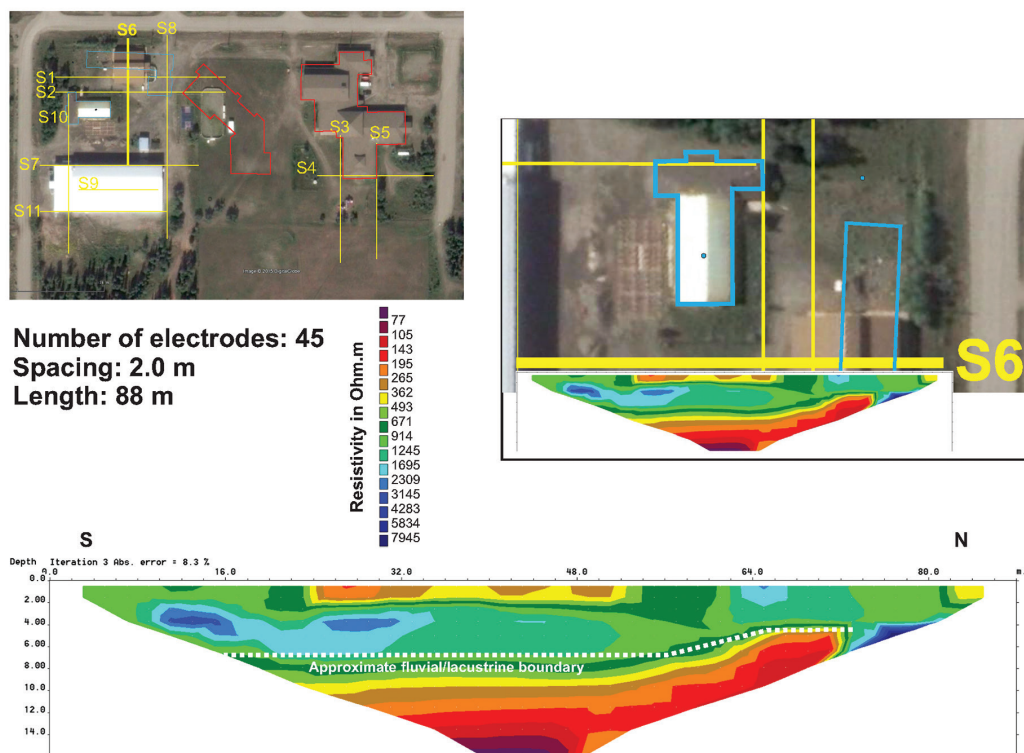
Figure 3.4.3 ERT survey S6, made east of the pool and community centre, oriented south/north

Survey S6 (Figure 3.4.3) was made east of the pool and community centre and was oriented north/south. Low resistivity areas were detected between 32 to 48 m (deeper in the profile) and between 66 to 74 m (closer to the surface) along the survey line. In this profile, the borehole logs indicate that the top of permafrost is at about 9–10 m depth and the contact between gravel and silt is less deep (about 7 m). This makes it difficult to distinguish the influence of the soil texture from that of the thermal state. The data suggest, however, that the first area of low resistivity coincides with the area where the pool has leaked, while the second area can be attributed to either the former curling rink and/or the present-day community centre. Some high resistivity sections were detected at the south and north ends of the profile. These coincided with open areas that are free of buildings and vegetation. The soil may still have been seasonally frozen at the time of the survey.

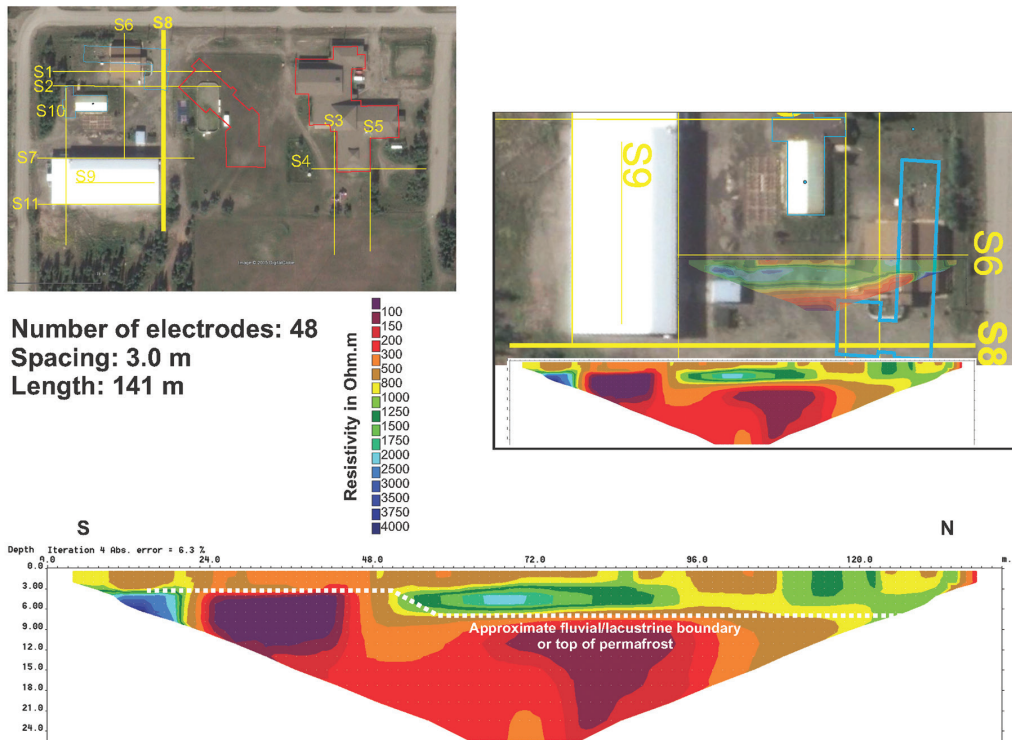
Figure 3.4.4 ERT survey S8, made 40 m east of the pool and community centre, oriented south/north

Survey S8 (Figure 3.4.4) was parallel to S6, but about 25 m east of it. The survey shows similar results to S6, but with a larger scope. Low-resistivity areas were recorded between about 24 to 45 m and about 70 to 95 m (deeper in the profile) along the survey line. The first low-resistivity area is located in front of the arena. This could be attributable to the presence of the building or/and disturbance by the meltwater from the skating rink each spring. The second low-resistivity area is consistent with the one observed in S6. It is bulb-shaped and starts at about 9 m depth. Although it is 40 m away

from the pool, it matches the shape of the low resistivity area observed in S6, indicating that it is also part of the zone that has been influenced by the pool. Disturbances from the former school may also contribute to this low-resistivity zone.

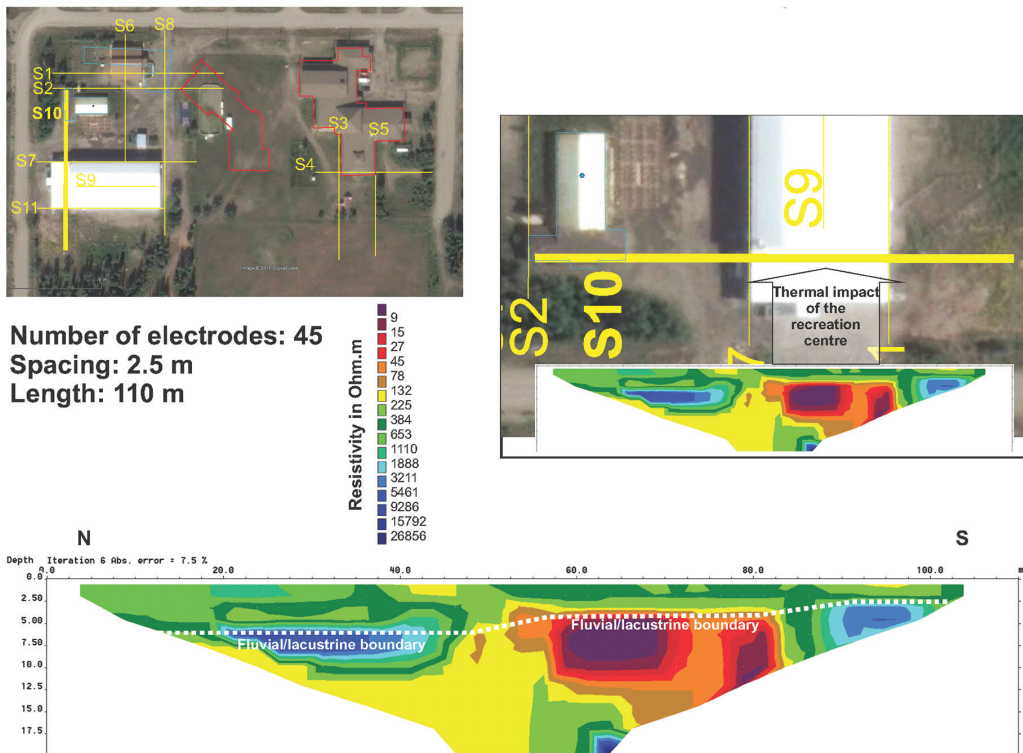
Figure 3.4.5 ERT survey S10, made west of the pool and arena, oriented north/south

Survey S10 (Figure 3.4.5), oriented north/south, clearly shows the impact of the recreation centre on the permafrost. Lower resistivity (red in the profile) is visible between about 60 and 80 m on the survey line. This impact appears to continue down to about 13 m. Two higher-resistivity areas occur from about 20 to 45 m and from 87 to 100 m. Those coincide with open areas where snow is not likely to accumulate in winter. The boundary between fluvial and lacustrine sediments is assumed to slope from about 2.5 m depth at the north end of the profile to about 6 m at the south end.

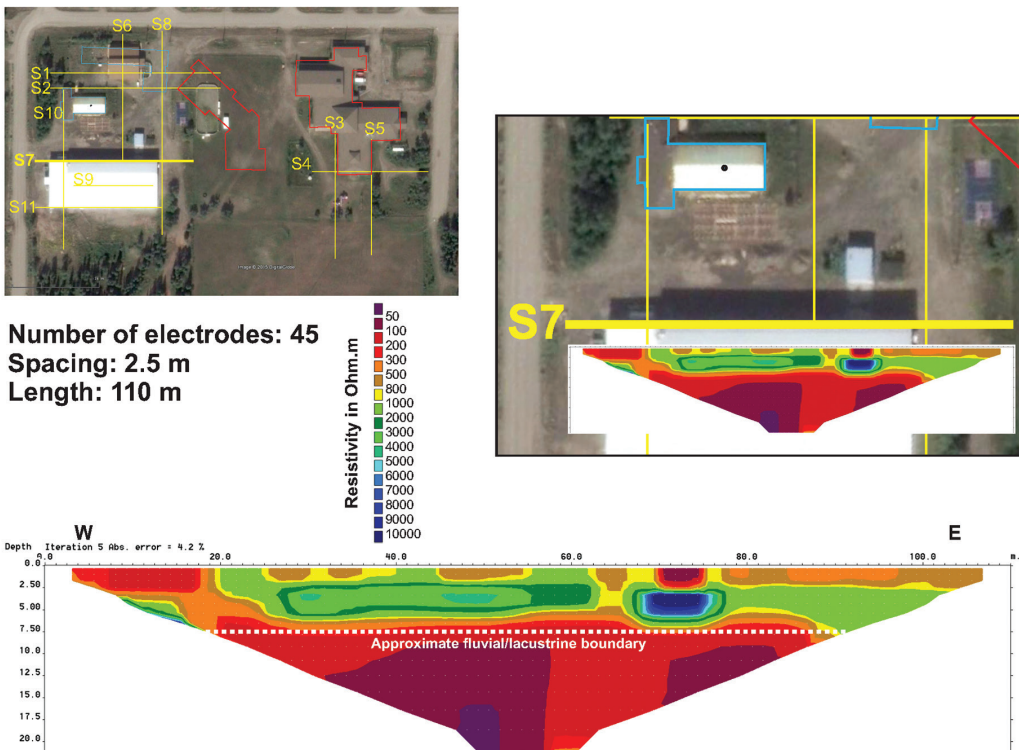
Figure 3.4.6 ERT survey S7, made along the north side of the recreation centre/arena , oriented west/east

Survey S7 (Figure 3.4.6) was done along the north side of the arena/recreation centre. It was oriented west/east. The profile shows a transition between resistive and less resistive material at about 7.5 m depth, around the 300 Ohm.m threshold. This transition may indicate the boundary between gravelly alluvial sediment and silty lacustrine material. Based on the observations around the community centre, permafrost may still be present, but very warm. Shade from the building may favour the preservation of seasonal frost (shown as higher resistivity) that was observed in the gravel in the upper part of the profile.
