Assessment of Risk to Infrastructure from Permafrost Degradation and a Changing Climate, Ross River

Calmels, F., B. Horton, L.P. Roy, P..Lipovsky.and.B. Benkert, 2016. Assessment of Risk to Infrastructure from Permafrost Degradation and a Changing Climate, Ross River. Northern Climate ExChange, Yukon Research Centre, Yukon College.

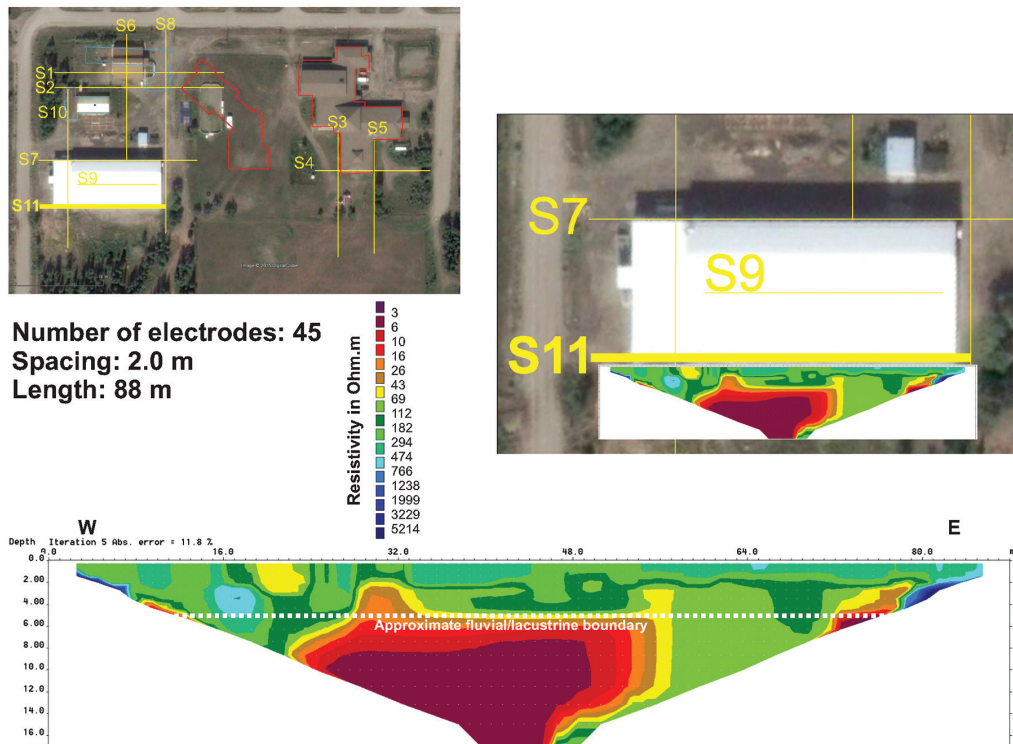
Figure 3.4.7 ERT survey S11, made along the south side of the recreation centre/arena, oriented west/east

Survey S11 (Figure 3.4.7) was done along the south side of the arena/recreation centre. It was oriented west/east. The profile is similar to S7, with a threshold between resistive and less resistive material. In S11, the threshold is shallower than on the north side (in S7); it is about 5 m depth and around the 70 Ohm.m threshold. The lower-resistivity threshold may be due to the south-facing aspect creating warmer ground temperatures and a deeper permafrost table. The higher gravel/silt boundary is consistent with the observations in survey S10. The low-resistivity area observed between about 20 to 50 m may be attributable to the drainage of the meltwater from the rink. External factors such as previous buildings or localized snow drifting may also be relevant.

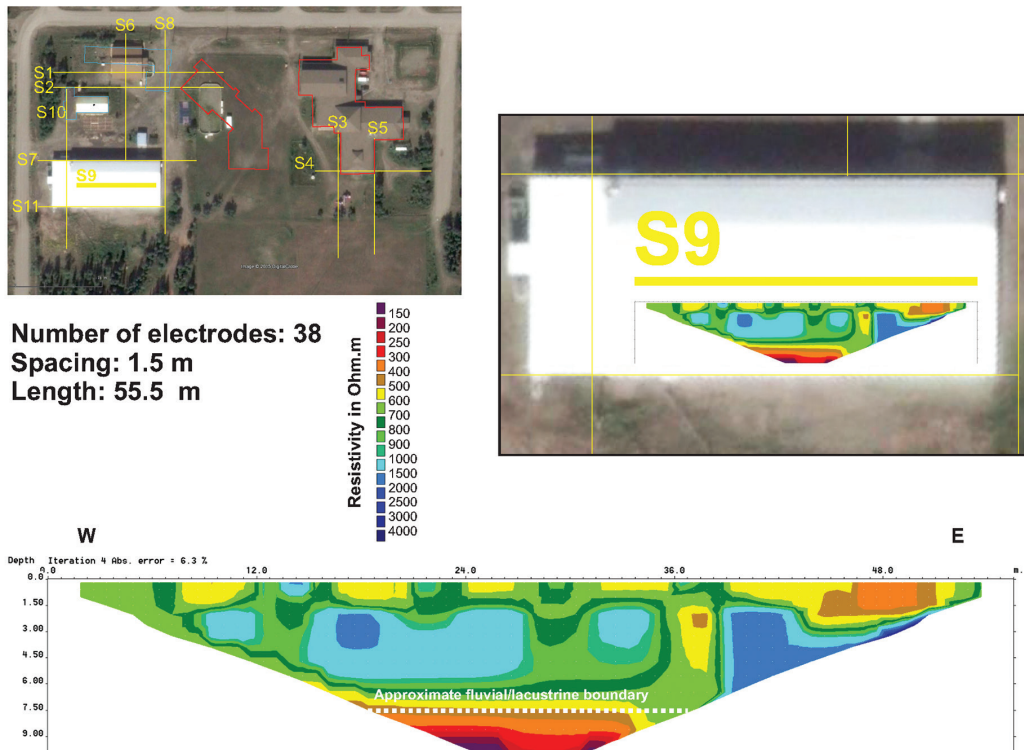
Figure 3.4.8 ERT survey S9, made in the middle of the arena rink, oriented west/east

Survey S9 (Figure 3.4.8) was made in the middle of the arena rink, and oriented west/east. This was a short survey, with electrodes placed closer together than usual. The resulting profile is limited in depth to about 10 m, but with higher resolution. Like several other surveys, this survey indicates a contact between gravel and silt at about 7.5 m. The resistivity is similar to that detected on the north side of the arena.

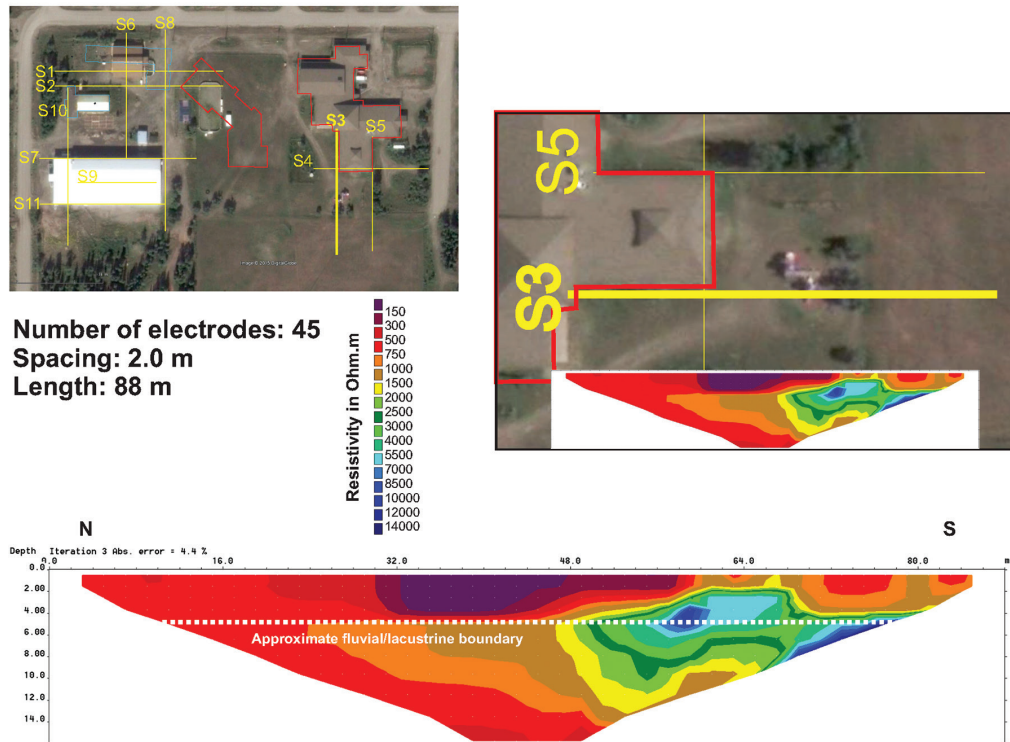
Figure 3.4.9 ERT survey S3, made on the west side of the school’s south wing, oriented north/south

Survey S3 (Figure 3.4.9) was performed on the west side of the south wing of the school, and was oriented north/south. A sharp transition is indicated at about 5 m, where resistivity is near 750 Ohm.m. The logs of nearby boreholes show the limit between fluvial coarse (gravel) and fine lacustrine (silt) sediment at 6 m depth (1200096-BH05) and 4 m depth (13117.2-BH03; see Figure 3.2.1 and Annex). As a result, it can be assumed that the threshold observed on the ERT profile is attributable to the gravel/silt limit. Resistivity values are very low in front of the south end of the wing. This may be due to moisture in the ground or/and the southern exposure. Resistivity values are higher at the southern end of the profile, beginning at about 50 m. This coincides with the playground and sports areas, where the field is exposed and not subject to the impact of the school; in addition, snow is likely either compacted here by wind and children playing outdoors or is blown clear of the area.

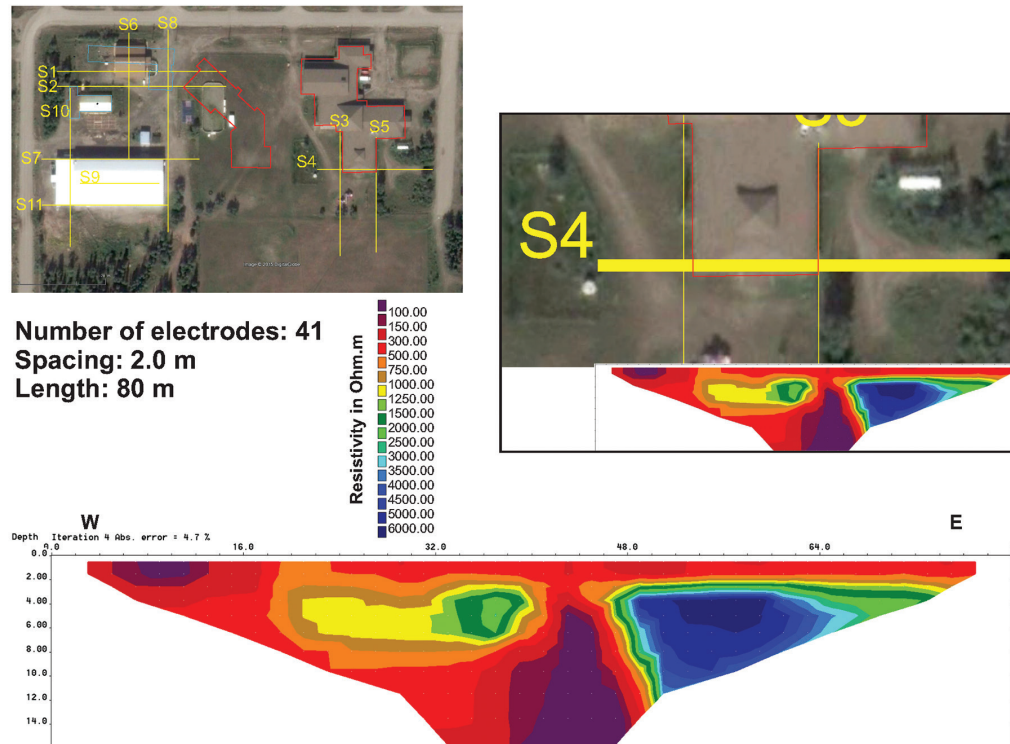
Figure 3.4.10 ERT survey S4, made on the south side of the south wing of the school, oriented west/east

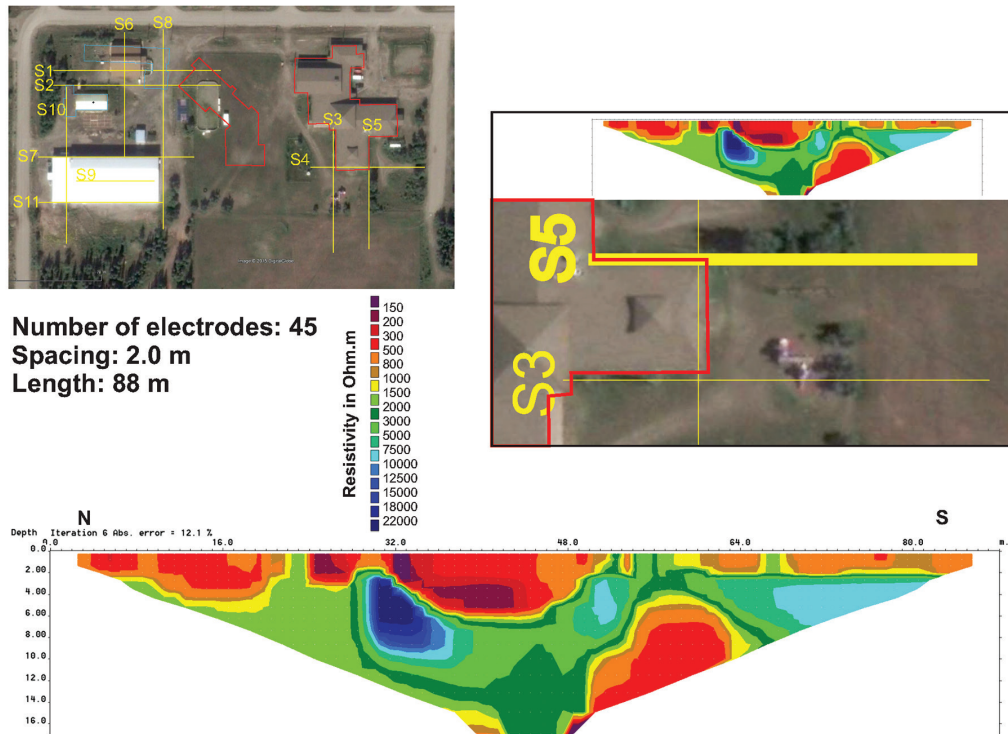
Figure 3.4.11 ERT survey S5, made on the east side of the south wing of the school, oriented north/south

Survey S5 (Figure 3.4.11), oriented north/south, was made on the east side of the south wing of the school. The low-resistivity area observed between about 0 and 20 m can be attributed to the thermal impact of the building. A high-resistivity area at about 30 m is located in an open area between the school and the fence. Lower resistivity characterizes the area between 32 and 52 m, where there is a fence and shrubs. Low resistivity is observed at about 60 m, where there is a south-facing slope from the schoolyard toward the baseball field, and where the exposure and the snow accumulation, packed by the wind during winter, may contribute to ground warming. High resistivity was observed in the open, where the baseball field is located.

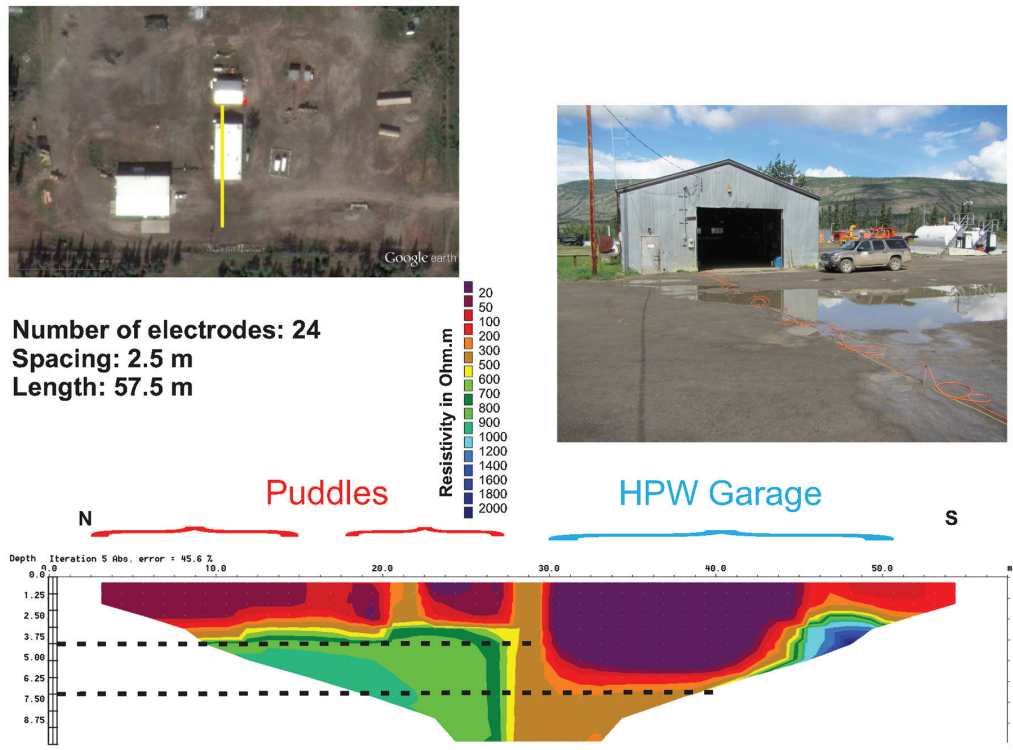
Figure 3.4.12 ERT survey made through the HPW grader station, oriented north/south

An additional ERT survey, oriented north/south, was performed in a garage of the HPW grader station, on the road entering the community (Figure 3.4.12). The building has been affected by permafrost thaw, and the objective of the survey was to see whether an ERT assessment was feasible across a building with a concrete slab foundation. Although it was difficult to get electricity to pass through the concrete slab, the data that was obtained suggest a permafrost table and/or a gravel/silt limit located at 4 m depth in the vacant lot and a permafrost table at 7 m depth below the garage.

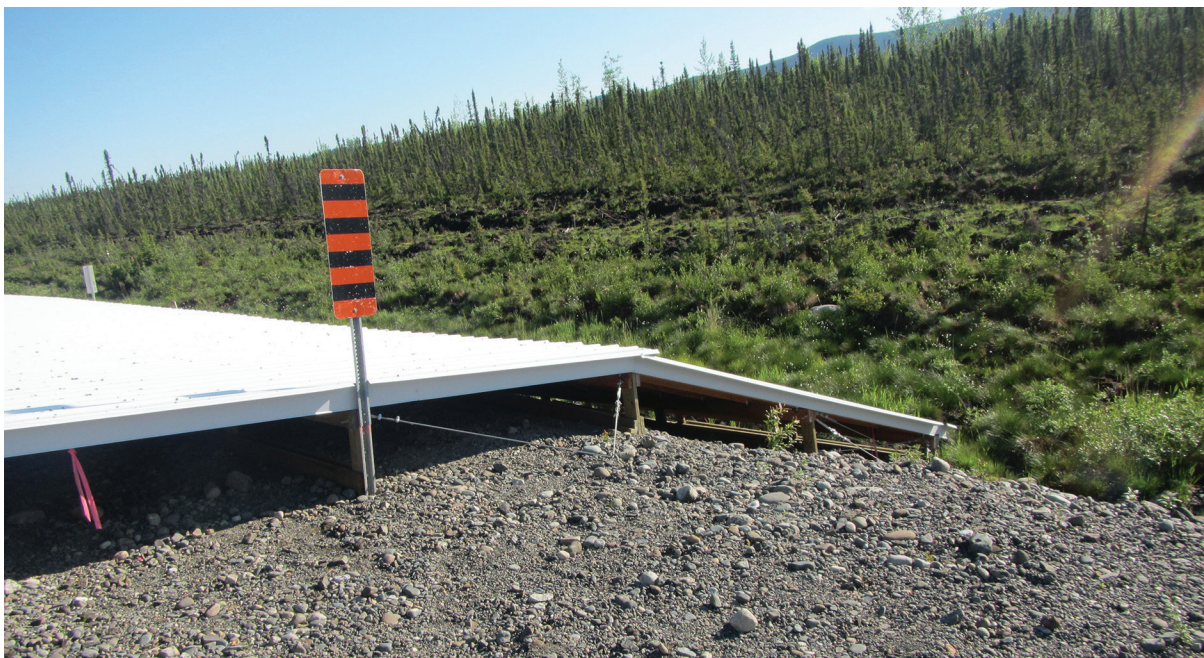
Figure 5.1 Snow shed used to preserve permafrost along the Alaska Highway

Other shading techniques may also be of use. For example, snow sheds in use along a test section of the Alaska Highway outside of Beaver Creek have proved to be efficient (Figure 5.1). They prevent snow from accumulating directly on the ground and also shade the ground surface while allowing air flow. The school could be a potential candidate for such a technique because it would not involve modification of the building.
